LAND CORNER RECORDATION CERTIFICATE
Filing Requirement of Act 74, Mich. P.A. 1970

1. Public Land Survey	T <u>43N</u> R <u>28W</u>	<u>EB</u>
	T <u> </u> R <u> </u>	<u> </u>
	T <u> </u> R <u> </u>	<u> </u>
	T <u> </u> R <u> </u>	<u> </u>
2. Property Controlling in Section	S <u>28</u> T <u>43N</u> R <u>28W</u>	<u>1</u>
	S <u> </u> T <u> </u> R <u> </u>	<u> </u>
3. Miscellaneous Property in Sec.	S <u> </u> T <u> </u> R <u> </u>	<u> </u>
	S <u> </u> T <u> </u> R <u> </u>	<u> </u>

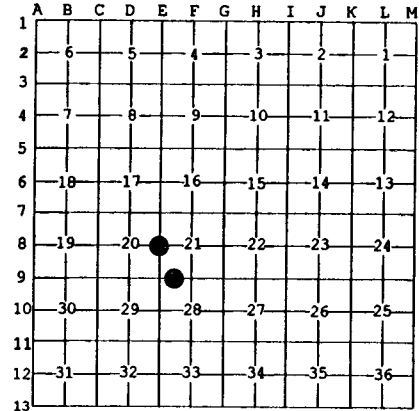
A. Description of original monument and accessories and/or subsequent restoration:
 (EB) Quarter corner common to Sections 20-21. Remonumented in the original position from two W.Pine 08T stumps by Billy D. Buckler RLS in 1962. 1" pipe with 4" aluminum cap. 12" B.Ash N37W 57 links, 5" B.Ash N62E 93 links.
 (1-Sec. 28) West 1/16 corner between sections 21-28. Established in 1963 by Billy D. Buckler RLS midway and on line between Section and Quarter corners. 1" iron pipe with 4" aluminum cap and wood post. 7" B.Spruce N78W 12 links, 9" Cedar S65E 27.5 links.

(EB) Recovered the 1962 monument as described, firmly set, in good condition, and at record bearing and distance from the decayed burned remains of the original BT W.Pine N11W noted in Buckler's record, and from the two 1962 NBTs. It appears that the distances to these two trees were transposed on the record. Both B.Ash NBTs are now down with scribing visible on the NW and blazes visible on the stump and bole of that NE. Left the monument in place and made new witnesses as described below. The edge of the Ford River is 32' S'yly. OH power lines are 11' SE'yly.
 (1-Sec. 28) Recovered the 1963 monument as described, in good condition, and at record bearing and distance from the two witness trees. The Cedar is in good condition with scribing visible, and the Spruce is dead and down. Left the monument in place and marked new witnesses as described below.

(EB) Found 1" ID iron pipe with 4" alum. MDOC cap. Blazed and scribed:	(1) Found 1" ID iron pipe with 4" alum. MDOC cap. Blazed and scribed:
15" B.Ash S88E 44.8' "1/4S NBT"	17" Cedar S09W 80.8' "1/16S BT"
7" B.Ash S53E 33.3' do	7" Cedar N31W 42.7' do
13" B.Ash N79W 34.2' do	10" Cedar N21E 30.1' do
18" W.Spruce N7W 50.0' do	11" Cedar S69E 18.4' (the 1963 NBT)
Sq'd cedar post adjacent. Bearings are magnetic. Distances are to notch in lower blaze.	Sq'd cedar post adjacent. Bearings are magnetic. Distances are to notch in lower blaze.
