**LAND CORNER RECORDATION CERTIFICATE**  
**Filing Requirement of Act 74, Mich. P.A. 1970**

For corners in  
Dickinson  
 (County)

Located In:	Corner Code #
1. Public Land Survey	T 43N R 28W F9
	T R
	T R
	T R
2. Property Controlling in Section	S 28 T 43N R 28W 3
	S T R
3. Miscellaneous Property in Sec.	S T R
	S T R

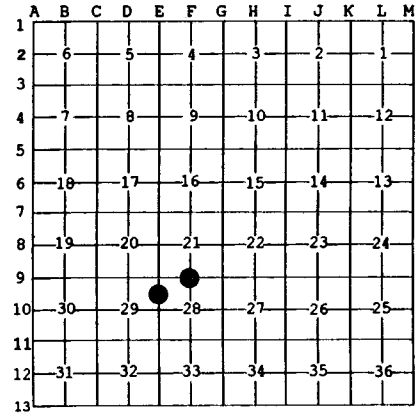
(F9) Quarter corner common to Sections 21-28. Reestablished in 1963 by Billy D. Buckler RLS, midway between Section corners. 1" Iron pipe with 4" aluminum cap and wood post. 7" Cedar S07E 13 links, 5" Balsam S74W 3.5 links.  
 (3-Sec. 28) North 1/16 corner between Sections 28 and 29. Established in 1963 by Billy D. Buckler. 1" iron pipe with 4" aluminum cap and wood post. 5" Maple N75W 34 links, 6" Maple N33E 47 links.

(F9) Recovered the 1963 monument, disturbed, laying on the ground. Remonumented the corner at record bearing and distance from the two 1963 NBTs: the Cedar in good condition with overgrown blazes, and the Balsam, dead and down with blazes and scribing visible.  
 (3-Sec. 28) Recovered the 1963 monument as described, in good condition, and at record bearing and distance from the 1963 NBTs. The Maple NW is green with overgrown blazes, the Maple NE is now a decaying stump. Left the monument in place and made new witnesses as described below.

(F9) Set 1" ID iron pipe with plastic cap "MICH DNR PS33986". Blazed and scribed:	(3) Found 1" ID iron pipe with 4" alum. MDOC cap. Blazed and scribed:
20" Cedar S54W 9.5' "1/4S NBT"	12" Oak S02E 33.2' "1/16S BT"
12" Cedar N53W 31.2' do	7" triple Y. Birch N27E 29.1' do
10" Spruce N70E 12.0' do	7" Sugar N17W 34.2' do
Cedar S07E 8.6' (the 1963 NBT)	11" Maple N70W 22.45' (1963 NBT)
Sq'd cedar post adjacent. Bearings are magnetic. Distances to notch in lower blaze.	Sq'd cedar post adjacent. Bearings are magnetic. Distances are to notch in lower blaze.
