LAND CORNER RECORDATION CERTIFICATE
Filing Requirement of Act 74, Mich. P.A. 1970

For corners in
Dickinson

1. Public Land Survey	T <u>43N</u> R <u>29W</u>	<u>68</u>
	T _____ R _____	_____
	T _____ R _____	_____
	T _____ R _____	_____
2. Property Controlling in Section	S <u>18</u> T <u>43N</u> R <u>29W</u>	<u>1</u>
	S <u>15</u> T <u>43N</u> R <u>29W</u>	<u>2</u>
3. Miscellaneous Property in Sec.	S _____ T _____ R _____	_____
	S _____ T _____ R _____	_____

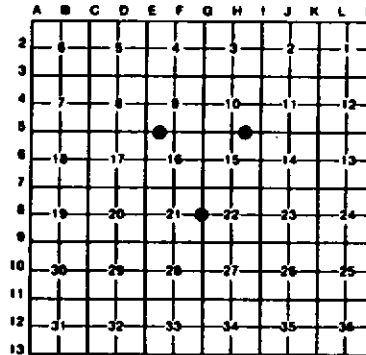
(2) Set 1" pipe with 4" MNHR cap. Blazed and scribed the following bearing trees:

4" Maple S43E 4.4' 1/16S BT"
 4" Balsam Fir S30W 6.4' 1/16S BT"
 6" Maple N69W 36.5' (on slope) 1/16S BT"
 5" Maple N39E 16.9' (on slope) 1/16S BT"
 Squared a 4" W. Birch N23E 4.3'
 Bearings are magnetic.
