SURVEY & REMONUMENTATION

1996 REMONUMENTATION PROGRAM
LAND CORNER RECORDATION CERTIFICATE
Filing Requirement of Act 74, Mich. P.A. 1970

I, Jack N. Owens, P.S., in a field survey on October 25, 1996, do hereby certify that under requirements of P.A. 74, Michigan P.A. of 1970, the corner points mentioned in lines 1 and 2 above were in conformance with regulations and rules therefore as required in the current manual of survey instructions of the United States Department of the Interior, Bureau of Land Management or by a decree of a Court of Law and/or that the corner points mentioned in lines 3, 4 and 5 above were in conformance with the rules of the Michigan Board of Land Surveyors or by a Decree of a Court of Law; established, re-established, monumented, re-monumented, recovered, found as expressed below:

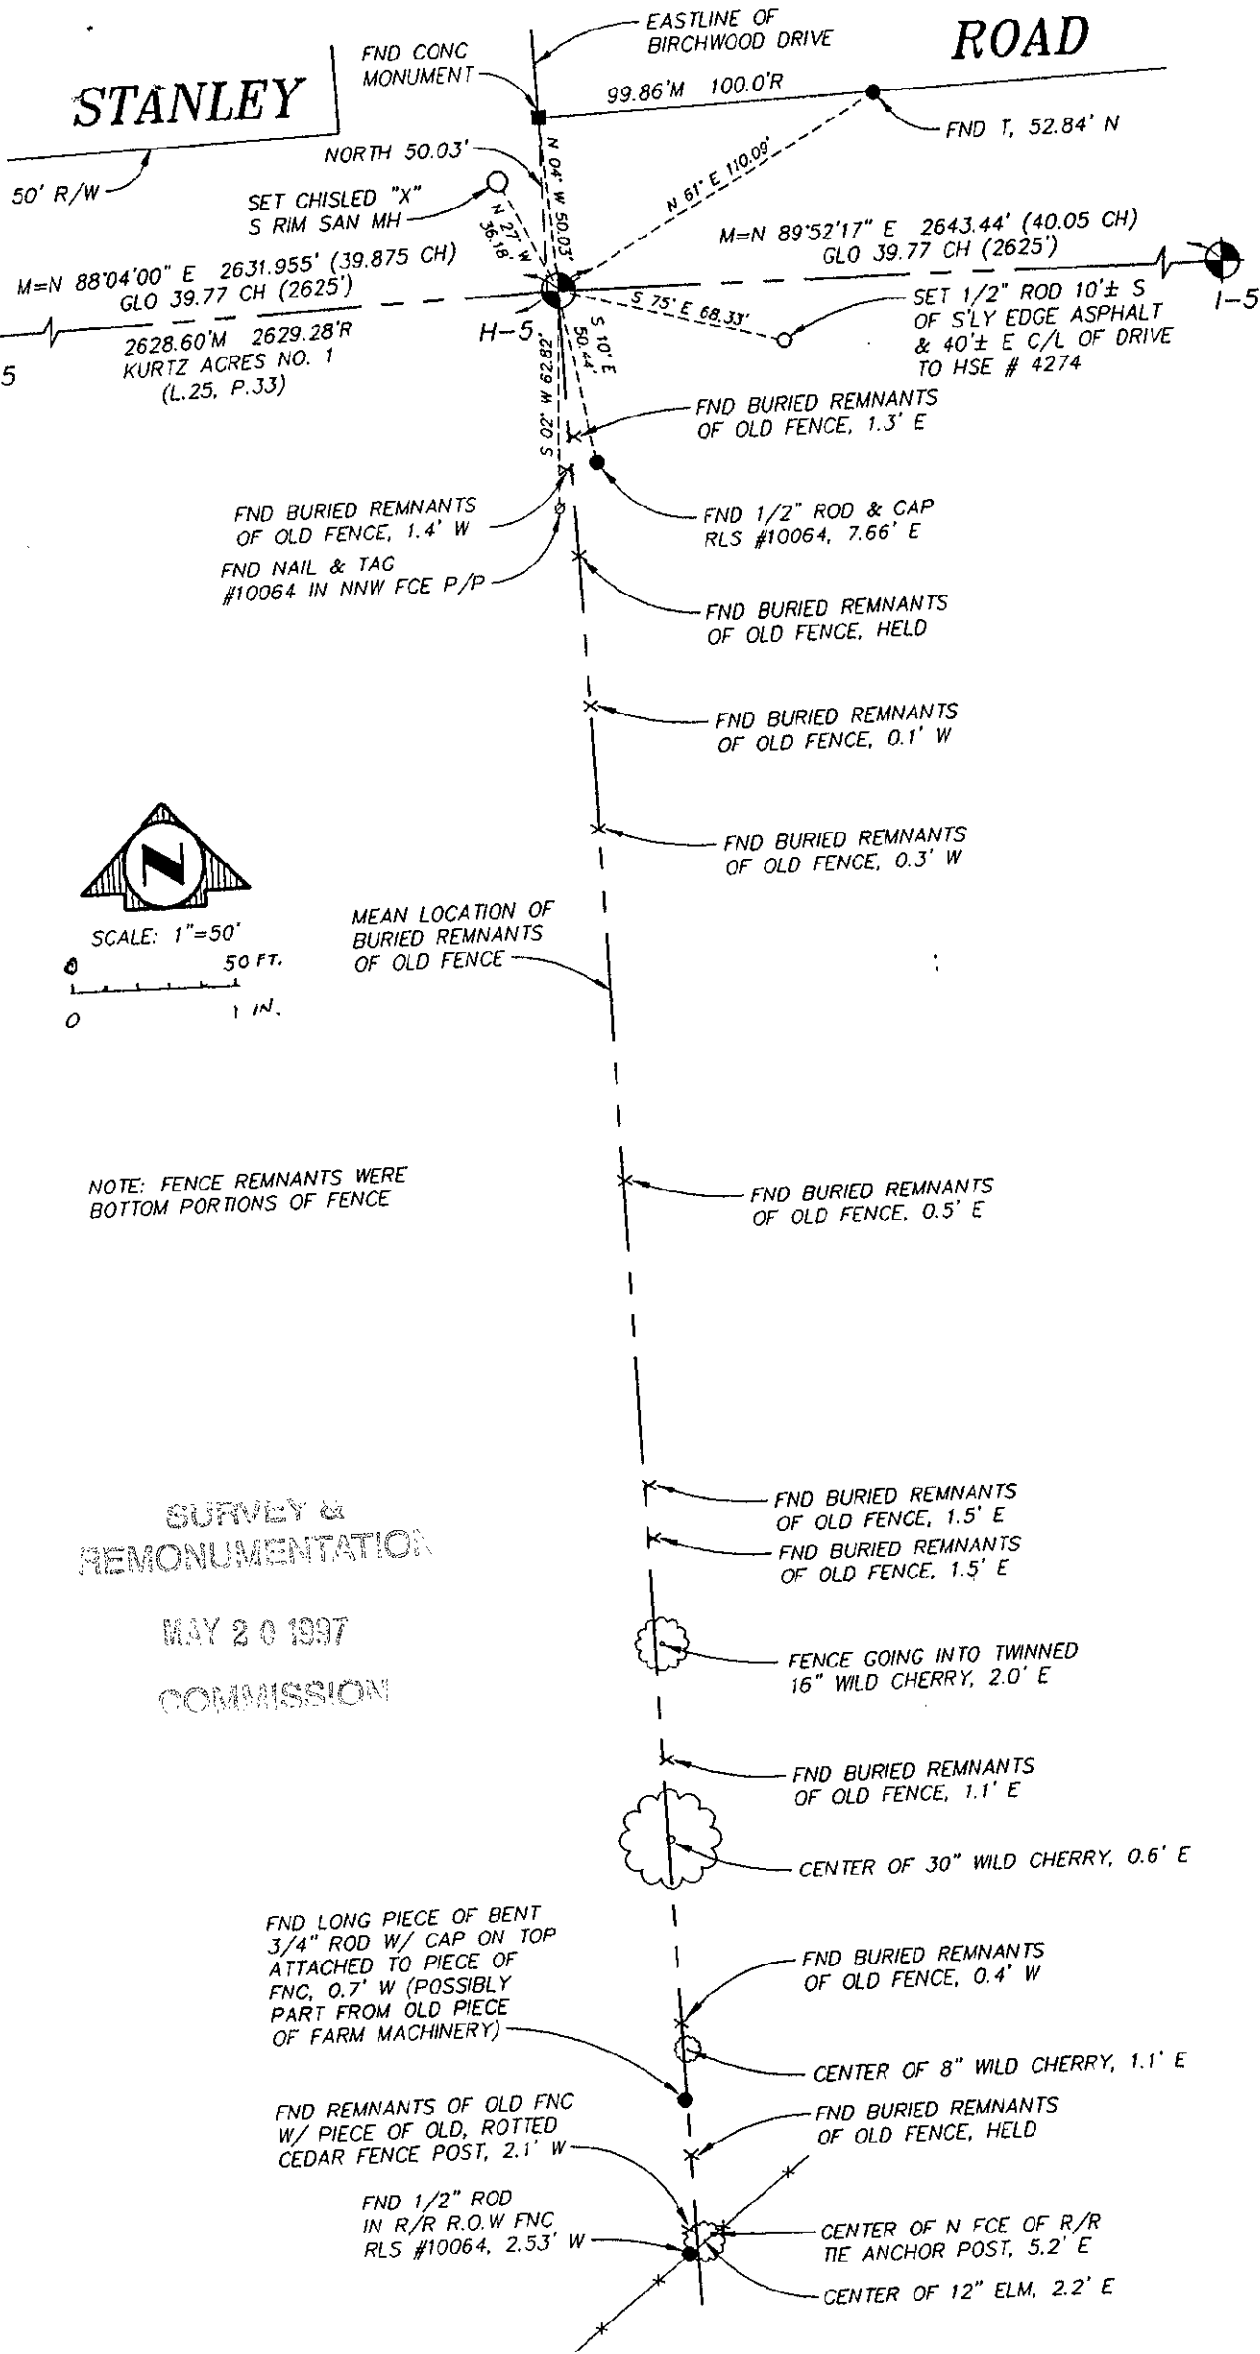
EASTLINE OF BIRCHWOOD DRIVE ROAD

NOTE: FENCE REMNANTS WERE BOTTOM PORTIONS OF FENCE

B. Description of corner evidence found and/or method applied in restoring or reestablishing corner:
Determined position for H-5 by retracing old N-5 1/4 line fence Section 15, T8N-R7E.
The only record we could recover that describes a monument at the corner H-5 was the G.L.O. notes when the corner was actually set. Since that time no one, including GCRC when Stanley Road was paved, has reported having the corner or accessories to it. When we first visited H-5, we were not surprised to find nothing monumenting the position of the corner. We were curious as to what it was that Mr. West must have been looking at when he was platting all of that property in Section 10. It appeared that he had some indication of the position of H-5, but he never gave a dimension to the corner to exactly define its position. We decided to look at some old county aerial photography to see what evidence of the North-South 1/4 line could be seen. We obtained an aerial photograph from 1966, (prior to the construction of Mott Dam). This photograph showed a well defined N-S 1/4 line in Section 15. The line is an old fence line with several large trees along it, and (Cont'd on back)

C. Description of monument for corner and accessories established to perpetuate locating the position of the corner:
N04W 50.03' Found conc. Monumnt at SW corner Lot 45, "Kurtz Acres No. 1", L.25, P.33
N61E 110.09' Found "T" iron at SE corner Lot 45, "Kurtz Acres No. 1", L.25, P.33
S75E 68.33' Set 1/2" rod (TP) 10' South of S'ly edge Asph. & 40' East of C/L drive to Hse #4274
S10E 50.44' Found 1/2" rod & cap RLS #10064
S02W 62.82' Found Nail & Tag RLS #10064 in NNW face P/P
N27W 36.18' Set chisled "+" in South rim Sanitary MH
Ratified by Genesee County Peer Group November 20, 1996. I set the Standard Berntsen Monument SS-A-5-BR-30 (3 1/4" D. brass cap stamped "Genesee County Remonumentation Corner 20709, 1996") with 30 x 2 3/8" O.D. stainless steel tubing.

appeared very straight on both the North and South sides of the Flint River. From this we conclude that the North-South 1/4 line location is a result of a survey subdividing Section 15. It likely was done by one of the County Surveyors from 1865-1900 when several were practicing in the County. When not holding the office they were not required to record their surveys, yet they followed the same procedures to subdivide sections. We then obtained an aerial photograph taken in 1992 of the same area and looked for similarities between the two photos. We noticed two large trees that appeared on both photos. We concluded that this old North-South fence was not only the best collateral evidence of the corner locations, but also the only evidence left. We next field located this N-s 1/4 line fence and trees along the fence and used it to locate a line through these points North and intersect it with the South Line of Section 10 as recorded on "Kurtz Acres No. 1", Mark W. Powell, Crew Chief recovered a RLS #10064 tag in the NNW face of a power pole to the South. After further investigation Mark also found a 1/2" rod and cap RLS #10064, and an old railroad tie anchor post, 50' from the center line of Stanley Road and at the rear of the property he found another 1/2" rod & cap RLS #10064, and an old railroad tie anchor post, both of which were in the N'y right of way fence for the Huckleberry Railroad. Mark searched along the West line of a yard to a residence that had been built after 1966 for evidence of a fence or the 1/4 line, but the only visible remnants were the two trees that appeared in the aerial photographs. On the Southerly side of the railroad Mark could not find any evidence of a 1/4 line fence or any large trees in a row. The property had evidently been cleared after it had been acquired by the Genesee County Park Department. The cover was thick 4" poplars near the railroad, and opened into 4'-6" high thick tags and thornapple bushes near the lake. Mark began uncovering very old and brittle pieces of 4" x 4" square pieces of fence approximately 3" below the ground. He was only locating what he believed to be the bottom strand of the fence and by eyeballing a line using the large cherry trees determined that the fence had fallen to the East, because he also had dips at approximately 4'-5' further East of the tree line and the fence base he was uncovering. Mark then traversed between the corners G-5 and H-5, tied in a plat concrete monument and a "T" iron that were set by Mr. West, and then tied down all of the pieces of fence he had recovered (13 pieces in 500 feet) along with any other evidence of the location of the 1/4 line. Upon bringing all of this information into the office, Jack n. Owens, PS #20709, evaluated the evidence and determined an average location of the old N-S 1/4 line fence. He also concluded that the irons recovered bore not relationship to the old fence. He contacted Kraft Engineering for information regarding their survey but did not receive any records to indicate what their line represents. We conclude that the fence is the best evidence to establish the corner and that the corner is obliterated, not lost. The fence is just East of the E'y right of way of the platted road to the North, about 3.4 feet whereas the scaled distance on the plat is approximately 6 feet. It is not as definite as the fence remnants. Also the distance from G-5 to H-5 is only 10 links different than the G.L.O. record, a reasonable difference commonly seen in section retracement surveys. I accept the position as a careful and faithful re-established position of the original corner.
