SURVEY & REMONUMENTATION

LAND CORNER RECORDATION CERTIFICATE Filing Requirement of Act 74, Mich. P.A. 1970

<u>Leelanau</u>	Located In:	Corner Code #	
(County)			
1. Public Land Survey	T <u>29NR 11W</u>	<u>C-9 (Bingham Twp.)</u>	
	T ___ R ___	_____	
	T ___ R ___	_____	
	T ___ R ___	_____	
2. Property Controlling in Section	S ___ T ___ R ___	_____	
	S ___ T ___ R ___	_____	
3. Miscellaneous Property in Sec.	S ___ T ___ R ___	_____	
	S ___ T ___ R ___	_____

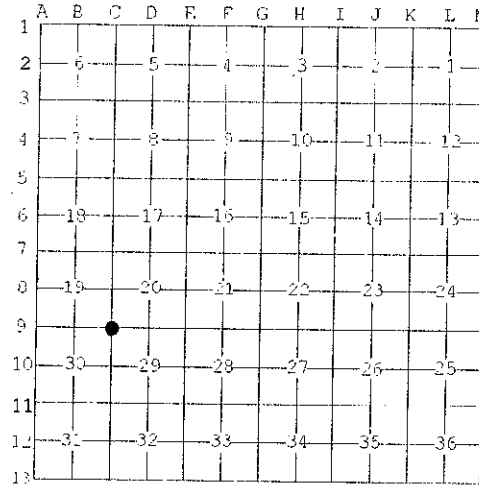
A. Description of original monument and accessories and/or subsequent restoration:
C-9: Southeast corner of Section 19.
G.L.O. notes: Set Post corner to Sections 19, 20, 29 & 30 at 80 chains.

B. Description of corner evidence found and/or method applied in restoring or reestablishing corner:
C-9: Southeast corner of Section 19.
Set 1/2" iron rod in 2" iron pipe found (Batzer - 1976). Found iron in monument box (Batzer - 1980).
Found 1/2" iron rod (O'Non - 1990).

C. Description of monument for corner and accessories established to perpetuate locating the position of the corner:
C-9: Southeast corner of Section 19.
Found 1/2" iron rod in monument box in the centerline of County Road 633 and accepted as the best available evidence of the position of the original corner by the Leelanau County Remonumentation Peer Review Group on December 8, 1998 and replaced with a 3/4" galvanized iron pipe 3' long with a brass cap.

Existing witnesses:
T. Pole stub (4' tall) S40°E 53.60'
P. Pole S83°W 112.91'
