LAND CORNER RECORDATION CERTIFICATE
Filing Requirement of Act 74, Mich. P.A. 1970

<u>Houghton</u> (County)	Located in:	Corner Code #
1. Public Land Survey	T <u>52N</u> R <u>35W</u>	<u>G6</u>
	T <u>52N</u> R <u>35W</u>	<u>H7</u>
	T _____ R _____	_____
	T _____ R _____	_____
2. Property Controlling in Section	S _____ T _____ R _____	_____
	S _____ T _____ R _____	_____
3. Miscellaneous Property in Sec.	S _____ T _____ R _____	_____
	S _____ T _____ R _____	_____

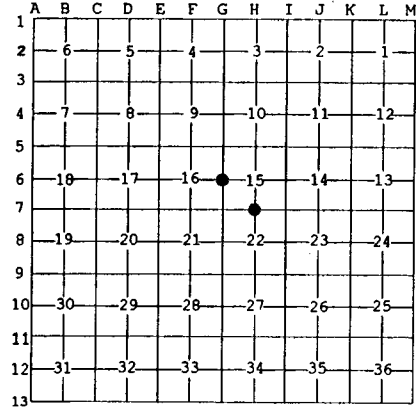
- A. Description of original monument and accessories and/or subsequent restoration:
 (G6) Quarter corner common to Sections 15-16. Corner established in 1846 by S.W.Higgins: Set 1/4 Sec. post. Y.Birch 14 N48E 16, Sugar 14 S45W 17. Corner re-monumented in the original position in 1953 by Dean C. DeLaMater, RLS: 1" pipe with 4" brass cap. 24" H. Maple S35E 25 links, 24" Hemlock West 42 links.
 (H7) Quarter corner common to Sections 15-22. Corner re-monumented in the original position by Dean C. DeLaMater in 1953. 1" pipe with 4" brass cap. 12" Y. Birch S53W 21 links, 12" Hemlock N65E 77 links.

- B. Description of corner evidence found and/or method applied in restoring or reestablishing corner:
 (G6) Recovered the 1953 monument as described, a 1" ID iron pipe capped with a 4" dia. brass Michigan Dept. of Conservation tablet, in good condition, and at record bearing and distance from the remains of the original Y.Birch bearing tree, now a rotting stump. The monument was recovered at record bearing and distance from the remains of the 1953 witnesses. The maple has rotted completely away with only root holes visible. The hemlock is a rotting stump. Left the monument in place and marked 4 new accessories as described below.
 (H7) Recovered the 1953 monument as described, a 1" ID iron pipe capped with a 4" dia. brass Michigan Dept. of Conservation tablet, in good condition, and at record bearing and distance from the remains of the 1953 witnesses. The Y.Birch is dead and down. The Hemlock is now a 20" dia. cut stump with part of lower blaze visible. Left the monument in place and marked four new accessories as described below.

- C. Description of monument for corner and accessories established to perpetuate locating the position of the corner:
 (G6) Found 1" pipe with 4" brass cap. Blazed and scribed the following:
 7" Sugar N45E 14.1' "1/4S NBT"
 9" Sugar S11E 15.2' do
 13" Hemlock S79W 27.8' do
 10" Y.Birch N43W 34.7' do
 Placed a squared cedar post adjacent. Bearings are magnetic. Distances are to notch in lower blaze.
 (H7) Found 1" pipe with 4" brass cap. Blazed and scribed the following:
 7" Maple N40W 6.35' "1/4S NBT"
 7" Balsam S59W 17.15' do
 8" Y.Birch S08E 13.15' do
 9" Maple S83E 17.7' do
 Placed a squared cedar post adjacent. Bearings are magnetic. Distances are to notch in lower blaze.
