LAND CORNER RECORDATION CERTIFICATE
Filing Requirement of Act 74, Mich. P.A. 1970

<u>Houghton</u> (County)	Located In:	Corner Code #
1. Public Land Survey	T 52N R 35W	G6
	T 52N R 35W	H7
	T R	
	T R	
2. Property Controlling In Section	S T R	
	S T R	
3. Miscellaneous Property in Sec.	S T R	
	S T R

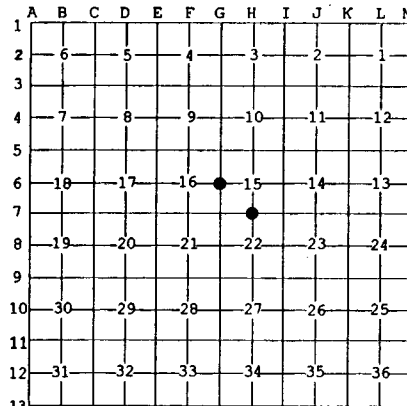
A. Description of original monument and accessories and/or subsequent restoration:

(G6) Quarter corner common to Sections 15-16. Corner established in 1846 by S.W.Higgins: Set 1/4 Sec. post. Y.Birch 14 N48E 16, Sugar 14 S45W 17. Corner remonumented in the original position in 1953 by Dean C. DeLaMater, RLS: 1" pipe with 4" brass cap. 24" H. Maple S35E 25 links, 24" Hemlock West 42 links.

(H7) Quarter corner common to Sections 15-22. Corner remonumented in the original position by Dean C. DeLaMater in 1953. 1" pipe with 4" brass cap. 12" Y. Birch S53W 21 links, 12" Hemlock N65E 77 links.

(G6) Recovered the 1953 monument as described, a 1" ID iron pipe capped with a 4" dia. brass Michigan Dept. of Conservation tablet, in good condition, and at record bearing and distance from the remains of the original Y.Birch bearing tree, now a rotting stump. The monument was recovered at record bearing and distance from the remains of the 1953 witnesses. The maple has rotted completely away with only root holes visible. The hemlock is a rotting stump. Left the monument in place and marked 4 new accessories as described below.

(H7) Recovered the 1953 monument as described, a 1" ID iron pipe capped with a 4" dia. brass Michigan Dept. of Conservation tablet, in good condition, and at record bearing and distance from the remains of the 1953 witnesses. The Y.Birch is dead and down. The Hemlock is now a 20" dia. cut stump with part of lower blaze visible. Left the monument in place and marked four new accessories as described below.
