LAND CORNER RECORDATION CERTIFICATE
Filing Requirement of Act 74, Mich. P.A. 1970 as Amended

<u>Iron</u> <small>(County)</small>	Located In:	Corner Code #	
1. Public Land Survey	T <u>41N</u> R <u>32W</u>	<u>H2</u>	
	T _____ R _____	_____	
	T _____ R _____	_____	
	S _____ T _____ R _____	_____	
2. Property Controlling in Section	S <u>4</u> T <u>41N</u> R <u>32W</u>	<u>14</u>	
	S _____ T _____ R _____	_____	
3. Miscellaneous Property in Sec.	S _____ T _____ R _____	_____	
	S _____ T _____ R _____	_____

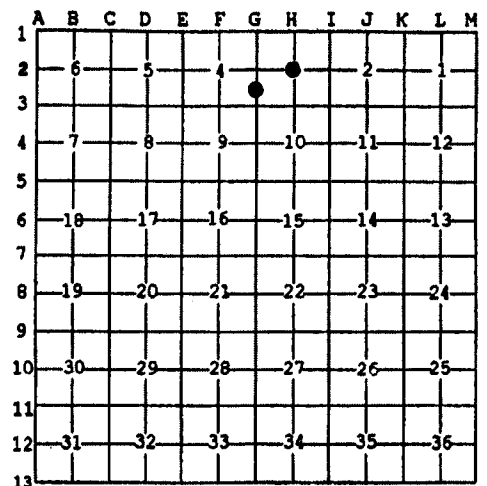
NOTE: Not more than 2 corners, all in the same town and range, may be recorded on this certificate.
