LAND CORNER RECORDATION CERTIFICATE
Filing Requirement of Act 74, Mich. P.A. 1970

For corners in
Iron

(County)	Located In:	Corner Code #/f
1. Public Land Survey	T 43N R 32W	D7
	T --- R ---	-----
	T --- R ---	-----
	T --- R ---	-----
2. Property Controlling in Section	S --- T --- R ---	-----
	S --- T --- R ---	-----
3. Miscellaneous Property in Sec.	S --- T --- R ---	-----
	S --- T --- R ---	-----

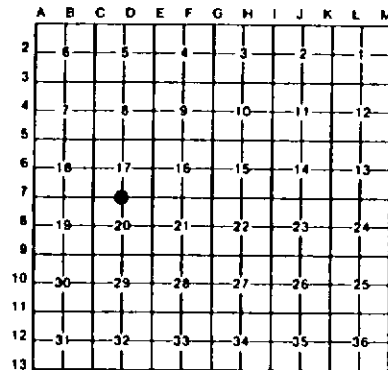
(D7) Quarter corner common to Sections 17-20. Corner established by Z.B. Searles, 1849 as follows: Set cedar post, Fir 10 S65E 18, Spruce 8 N70W 8. Original notes show the following along the true line (west) (1) 37.50 Descend ledge C. NE, (2) 40.00 Set Cedar Cr. Section post, (3) 44.21 W. Pine 12, (4) 62.28 Descend ledge 60 C.SSE, ... (5) 80.00 Section corner. Found no subsequent record.

(D7) Recovered a 3/4" iron pipe at the corner position, with a wood post adjacent and faced by a 12" cedar with an old blaze. Verified the position of the pipe with reference to the original record noted above: (1) found ledge as described at record distance east; (2) original post and accessories not recovered; (3) recovered burned W. Pine stump of proper size at record distance west, insufficient remains to identify markings; (4) found sheer ledge as described (490' west of the pipe; (5) recovered a 1" iron bar monument 2568.61' west (71 ft. shorter than record). Former owner of the SW1/4 of Section 17 John Giordana told me that this pipe was found in place by him when he acquired that parcel in 1962. I note that the pipe is also at the proportionate position with respect to the original record between the monumented SE corner of section 17 and the sheer ledge to the west. The substantial shortage to the section corner 17-18-19-20 is possibly due to the difficult terrain and river crossing west from the westerly ledge, and I accordingly place less weight upon the reliability of the original record of 40.00 chains to that corner from D7. Based on the above, I regard the position of the pipe as substantiated by the original record and accept it as the best available evidence of the position of the original corner. Replaced the pipe with a 1" I.D. x 32" iron pipe capped with a 4" dia. cast aluminum MDNR tablet, appropriately stamped. Placed the 3/4" pipe adjacent.

(D7) Set 1" I.D. pipe with 4" MDNR cap.
Blazed and scribed the following new bearing trees:
12" Cedar N07E 9.0' 1/4S NBT
9" Cedar N77W 70.3' 1/4S NBT
14" Cedar S79E 63.3' 1/4S NBT
Nail with MDNR tag in E. face P/P "CPT
B490 SPPS 430", S06E 47.93'
S84E 51.38' Found 5/8" iron pin
Set 6" cedar post squared and scribed
with location poster affixed, adjacent.
S84E 51.38' are magnetic.
