LAND CORNER RECORDATION CERTIFICATE
Filing Requirement of Act 74, Mich. P.A. 1970

<u>Iron</u> (County)	Located In:	Corner Code #	
1. Public Land Survey	T <u>43N</u> R <u>33W</u>	<u>C5</u>	
	T _____ R _____	_____	
	T _____ R _____	_____	
	T _____ R _____	_____	
2. Property Controlling in Section	S <u>8</u> T <u>43N</u> R <u>33W</u>	<u>15</u>	
	S _____ T _____ R _____	_____	
3. Miscellaneous Property in Sec.	S _____ T _____ R _____	_____	
	S _____ T _____ R _____	_____

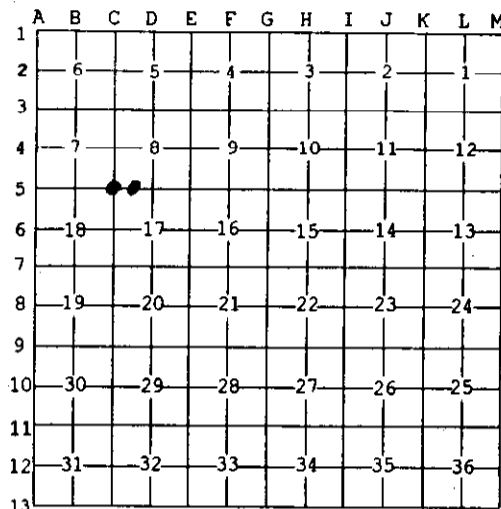
A. Description of original monument and accessories and/or subsequent restoration:
 (C5) Corner common to Sections 7-8-17-18. 1974: Reestablished by A.O. Enger RLS at the proportionate position between Section corners 1 mi. N and S. Set 1"IDx36" iron pipe with 3.5" aluminum cap. 18" Sugar Maple S75E 14.7', 10" Sugar Maple S35W 36.6', 10" Basswood N31W 13.7'.
 (15-Sec. 8) West 1/16 corner between Sections 8 and 17. Established by A.O. Enger in 1974 midway between Section and Quarter corners. 1"IDx36" iron pipe with 3.5" aluminum cap. W.Spruce 18 N08E 23.9', W.Spruce 14 S30E 8.7'.

(C5) Recovered the 1974 monument, leaning slightly to the SW and with a broken cap. Plumbed the monument to vertical and in accord with the stump remains of the Sugar S75E NBT and installed a new 4" dia. alum. cap. The other two NBTs have been destroyed by road construction. Checked the distance north to Sec. corner and found it to be 80.204 ch. (80.242 ch. 1974 meas.).
 (15-Sec. 8) Recovered the 1974 monument, leaning slightly to the SW. Plumbed the monument to vertical and in accord with the remaining NBT W.Spruce S30E. The monument falls on the steep slope of a hillside with a vertical drop 1.5' SW of the corner. Erosion of the hill has destroyed the other NBT. From the monument, I found the distance west to the Section corner to be 1317.50' and the distance east to 1/4 corner 1320.41'.

(C5) Found 1"ID iron pipe and installed new 4" dia. alum. MDNR cap. Blazed, scribed, and set measuring nails in: 9" Sugar N46E 17.0' "S8 NBT" 8" Sugar S24E 44.35' "S17 NBT" 9" Sugar S64W 50.1' "S18 NBT" 10" Maple N60W 26.05' "S7 NBT" Set squared cedar post adjacent. Bearings are magnetic. Distances are to nail with plastic tag.	(15) Found 1"ID Iron pipe with 3.5" alum. State of MI cap. Blazed, scribed, and set measuring nails in: 7" Balsam N13W 8.45' "1/16S BT" 8" Spruce S72E 8.4' do 7" Cedar S30W 14.05' do 16" Spruce S30E 8.7' (estimated notch) The 16" Spruce is the 1974 NBT with overgrown blazes. Bearings are magnetic. Distances to 2003 NBTs are to nail with plastic tag.
---	---
