LAND CORNER RECORDATION CERTIFICATE
Filing Requirement of Act 74, Mich. P.A. 1970

For corners in Iron (County)	Located In:	Corner Code #
1. Public Land Survey	T 46N R 34W	G4
	T 46N R 34W	H5
	T R	
	T R	
	T R	
2. Property Controlling In Section	S T R	
	S T R	
3. Miscellaneous Property In Sec.	S T R	
	S T R

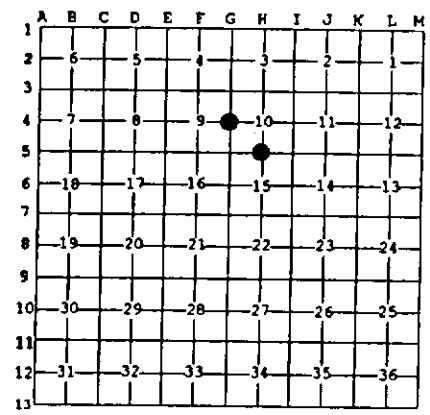
NOTE: Not more than 2 corners, all in the same town and range, may be recorded on this certificate.
