**JACKSON COUNTY
APPROVED LAND CORNER
P.A. 345 of 1990**

Chairman Alan L. Scheppelman NORTHEAST CORNER, SECTION 14, RIVES TOWNSHIP
Date 9-10-97 LAND CORNER RECORDATION CERTIFICATE
Filing Requirement of Act 74, Mich. P.A. 1970

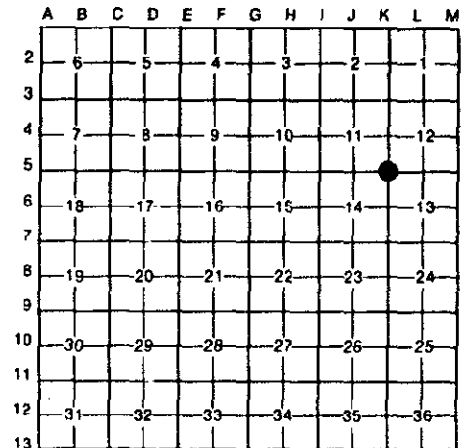
A. Description of original monument and accessories and/or subsequent restoration:

HERVEY PARKE, D.S. 80.00 SET POST CORNER SECTIONS 11,12,13 & 14
MARCH 12, 1825 B. ASH 10, S10°W 68 LINKS (44.88')
SWAMP OAK 16, WEST 87 LINKS (57.42')

HENRY F. BEAN 1885 FOUND OLD STAKE BY ONE WITNESS, ALSO FOUND THE REMAINS OF THE OTHER WITNESS.
ELM 10, N39½°W 89½ LINKS (59.07')
ELM 5, S87°E 7 LINKS (4.62')
