LAND CORNER RECORDATION CERTIFICATE

I-3 - Section corner common to Sections 2, 3, 10 and 11, T17N, R13W, Lake Co., Mi.

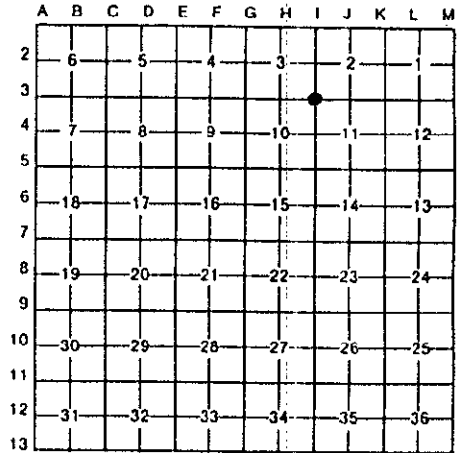
- 1-3 - Section corner common to Sections 2, 3, 10 and 11, T17N, R13W, Lake Co., Mi.
- 1838 - John Hodgson, G.L.O.
- #1 - 24" Pine S27°E 32 Links
- #2 - 24" Pine N33°W 6 Links
- 1928 - George Johnson, Co. Surveyor
- #5 - 16" B. Oak S70°45'E 74.5'
- #6 - 12" B. Oak N48°30'E 81.9'
- 1951 - George Blass, LS 5489
- Found 1" Iron Bar
- #7 - 8" W. Oak N54°W 53.7'
- #8 - 20" B. Oak N49°E 31.15'
- George Johnson, Co. Surveyor (Prior to 1928)
- #3 - 16" B. Oak S48°E 49.0'
- #4 - 14" B. Oak S24°W 59.0'

I found a 1-1/4" x 21" pointed rod directly over a 5/8" x 18" iron rod with remains of a wood stake. Along side of the irons I found a triangular shaped stone with 10" sides and 18" in length with a flat top. Condition of accessories are as follows: #1 Gone, #2 Gone, #3 Found in good condition, #4 Gone, #5 Found decayed stump, #6 Gone, #7 Found in good condition, #8 Gone. Corner is in road intersection.

- 28" B. Oak S42°E 49.50' (60d spike in S.W. side) (#3)
- 12" W. Oak N48°W 53.81' (60d spike in S.W. side) (#7)
- 10" Forked W. Oak S60°W 51.15' (60d spike in N.W. side)
- Center of Pitcher Pump N78°E 113.56'
