SURVEY & REMONUMENTATION

LAND CORNER RECORDATION CERTIFICATE
Filing Requirement of Act 74, Mich. P.A. 1970

G-11 - Section corner common to Sections 27, 28, 33 & 34, T18N, R12W, Cherry Valley Twp., Lake Co., Mi.

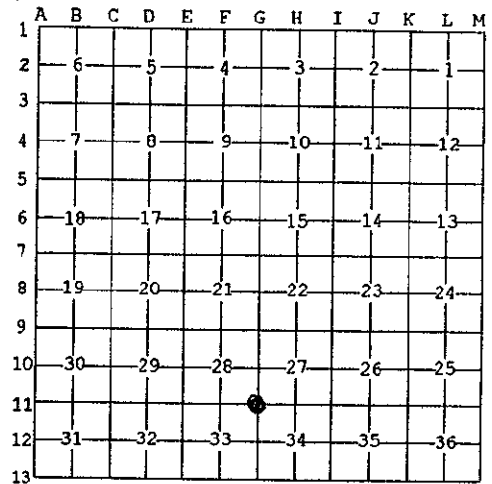
- 1838 - J. Hodgson, G.L.O. #1 - 10" Pine S9-1/4°E 5.16 Links #2 - 7" B. oak N33°E 55 Links
Undated - G. Johnson, Co. Sur. Iron Pipe #3 - 8" B. Oak N44°E 42' #4 - 7" B. Oak S64°E 58'
1922 - G. Johnson, Co. Sur. Developed plat of "Thompson's Villa". No accessories given. This corner is the S.E. corner of plat.

I found Griffin's 5" Concrete post in the intersection of road North, South, East and West. I also found a 1/2" iron pipe N27°29'E 3.72 feet from Griffin's post. I found monumentation from the plat of "Thompson's Villa" that confirms Johnson used this pipe in 1922. I also found monumentation in the plat of "Blass Park" (developed by George Johnson in 1924) in Section 33 that confirms Johnson used the position by Griffin. I believe the pointed stone and iron probably pre-date 1922 so I accepted Griffin's 5" Concrete Monument as the correct location.

Condition of the accessories are as follows: #1 Gone, #2 Gone, #3 Found in poor condition, #4 Gone, #5 Found in good condition, #6 Found dead, #7 Found in good condition, #8 Gone.

I accepted the 5" Concrete Monument as a substantial marker for the corner, and is accepted as a careful and faithful re-establishment of the position of the original corner.

- 29" W. Pine N46°E 114.32' (60d spike in S.E. side) #7
11" W. Oak N44°W 54.80' (dock spike in S. side) #5
5" R. Pine S54°W 111.17' (60d spike in N.W. side)
7" W. Pine N83°E 107.74' (60d spike in S. side)
Power Pole S54°E 77.35' (nail and tag in N. side) #9
