SURVEY & REMONUMENTATION

LAND CORNER RECORDATION CERTIFICATE
 Filing Requirement of Act 74, Mich. P.A. 1970

- E-5 - Section Corner common to Sections 8, 9, 16 & 17, T19N, R12W, Lake Co., MI.
- | | | |

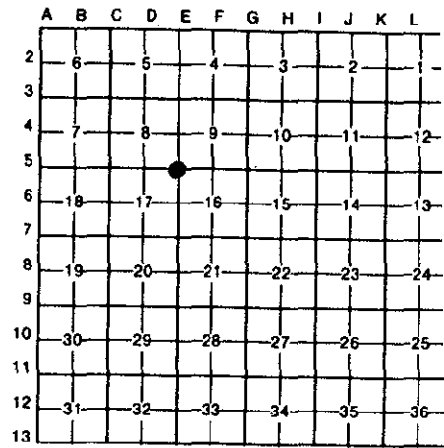
E-5 - Section Corner common to Sections 8, 9, 16 & 17, T19N, R12W, Lake Co., MI.

I replaced the "T" Iron Fence Post with a 3/4" x 24" re-bar with Lake County Brass Cap, and is accepted as a careful and faithful re-establishment of the position of the original corner.

- 6" W. Pine N65^oE 36.30' (60d spike in N.W. side) #7
- 12" R. Pine N55^oW 108.66' (60d spike in N.E. side)
- 12" & 16" Tw. B. Oak S2^oW 39.01' (60d spike in E. side) #6
- 7" W. Oak S55^oE 21.44' (60d spike in S. side) #5
- 7" R. Pine N32^oE 32.26' (60d spike in E. side)
- 13" W. Oak S82^oE 50.60' (60d spike in N. side)
