# LAND CORNER RECORDATION CERTIFICATE

For Corners In: Lake _____ (County)	Located In	Corner Code #
1. Public Land Survey	T <u>19N</u> R <u>12W</u>	<u>C2</u>
2. Property Controlling in Section	S _____ T _____ R _____	_____
3. Miscellaneous Property in Section	S _____ T _____ R _____	_____

I, Craig W. McVean, in a field survey on May 1, 2001 do hereby state that under requirements of PA 74, Michigan PA of 1970, the corner points mentioned in lines 1 and 2 above were in conformance with regulations and rules therefore as required in the current manual of survey instructions of the United States Department of the Interior, Bureau of Land Management or by a decree of a Court of Law and/or that the corner points mentioned in lines 3, 4 and 5 above were in conformance with the rules of the Michigan Board of Land Surveyors or by a Decree of a Court of Law; established, re-established, monumented, recovered, found as expressed below:

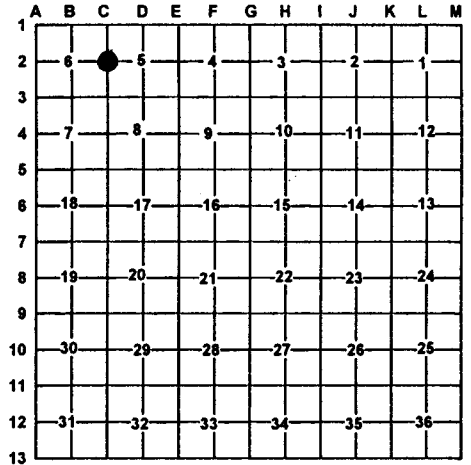
C2 – Replaced 'T' iron fence post with 4" DOC (DNR) Brass Cap on 1" X 36" galvanized iron pipe with 6" x 1' PVC filled with concrete around cap – down 0.7'  
 N88°E 32.99' to found ½" CIR # 13600 at SW side of cedar post with location tag  
 S18°E 96.40' to found ½" CIR # 13600 in concrete (CFR)  
 S66°E 37.77' to set N&T in SE side 10" B. Oak (CFR)  
 N46°E 50.94' to set N&T in SE side 13" R. Pine (CFR)  
 S68°W 61.98' to set N&T in N side 14" J. Pine (CC)

C2 – ¼ corner common to section 5 & 6, T19N, R12W.  
 Found 'T' iron fence post very rusted & 22" long per Cole & Roser. 2' East of center line N-S sand Rd.  
 Line of steel fence post goes easterly.  
 'T' fence post iron accepted as the best available evidence of the position of the original corner.
