LAND CORNER RECORDATION CERTIFICATE Filing Requirement of Act 74, Mich. P.A. 1970

E-6 - 1/4 Corner common to Sections 16 & 17, T20N, R11W, Lake Co., Mi.

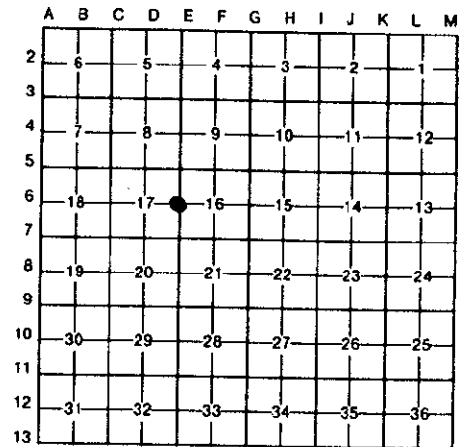
#1 - 10" Sugar S79°E 11 Links

#2 - 7" Beech N77°W 34 Links

#3 - 22" Elm N29°E 31.46'

#4 - Apple Clump S73°E 16.29'

#6 - Fence Post S60°W 37.90'

I found the 1/2" re-bar by Fletcher 6 feet East of center of North and South dirt road. I measured the entire mile between Sections 16 & 17 and Found this corner to be halfway and on line between Section corners (within 0.12 feet). The re-bar doesn't fit Nichoson's witness No. 3 by 4 feet more or less, but Nichoson set the corner by single proportionate method. So I accepted the 1/2" iron as found.

Condition of the accessories are as follows: #1 Gone, #2 Gone, #3 Found Stump, #4 Found in good condition, #5 Found in good condition, #6 Found in good condition.

I replaced the 1/2" re-bar with a 3/4" x 24" re-bar with Lake County Brass Cap, and is accepted as a careful and faithful re-establishment of the position of the original corner.

6" Apple in Clump S65°E 16.17' (Found nail N.E. side) #4

7" Elm N57°E 13.37' (60d spike in N.W. side) #5

6" Elm N19°E 56.03' (60d spike in N.W. side) #6
