**LAKE COUNTY REMONUMENTATION
LAND CORNER RECORDATION CERTIFICATE
Filing Requirement of Act 74, Mich. P.A. 1970**

Description of original monument and accessories and/or subsequent restoration:
 D-5 - 1/4 corner common to Sections 8 and 17, T20N, R14W, Elk Twp., Lake Co., Mi.

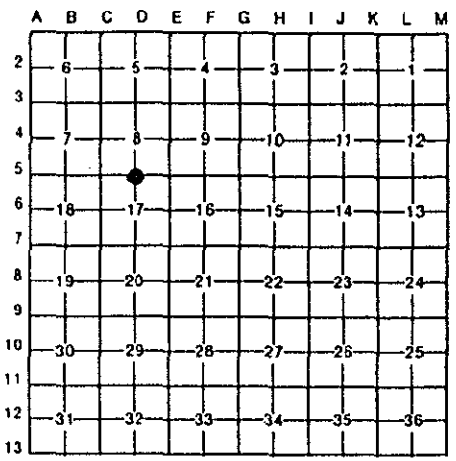
Description of corner evidence found and/or method applied in restoring or reestablishing corner:
 D-5 - 1/4 corner common to Sections 8 and 17, T20N, R14W, Elk Twp., Lake Co., Mi.

I found a 5" x 36" U.S.F.S. Concrete Monument 8" below the ground surface. I found all of Johnson's accessories (#3 & #4) and all of Cole's accessories (#5 thru #9).

I accepted the 5" x 36" Concrete Monument as a substantial monument for the corner, and is accepted as a careful and faithful re-establishment of the position of the original corner.

- 7" W. Oak S53°W 47.06' (Fd. 60d spike in N.W. side) O.B.T. #8
- 15" W. Oak N60°E 40.51' (Fd. Nail in N. side) O.B.T. #4
- 7" B. Oak S30°E 24.62' (Fd. 60d spike in W. side) O.B.T. #7
- 21" B. Oak N69°W 31.32' (Fd. Nail in S. side) O.B.T. #3
- 10" R. Pine N73°E 68.06' (Fd. 60d spike in S. side) O.B.T. #6
- 10" W. Oak S04°E 31.05' (Fd. Nail in E. side) O.B.T. #5
- 7" W. Pine N07°W 84.68' (Fd. 60d spike in W. side) O.B.T. #1
