LAND CORNER RECORDATION CERTIFICATE
Filing Requirement of Act 74, Mich. P.A. 1970

I-9 - Section corner common to Sections 22, 23, 26 & 27, T20N, R14W, Lake Co., Mi.

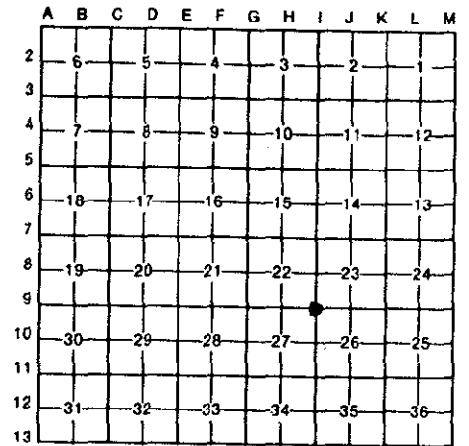
I found the 5" Square Concrete Monument by Griffin in intersection of roads East, West, North and South.

I accepted the 5" Square Concrete Monument as a substantial marker for the corner, and is accepted as a careful and faithful re-establishment of the position of the original corner.

Northeast corner School House Foundation S35°W 112.09'
24" and 18" Tw. W. Oak N24°E 104.36' (60d spike in E. side) #7
11" W. Oak N69°E 133.79' (60d spike in N.W. side)
Power Pole N31°W 51.64' (nail and washer in S.W. side) #10
