**LAND CORNER RECORDATION CERTIFICATE**  
 Filing Requirement of Act 74, Mich. P.A. 1970

Leelanau (County)	Located In:	Corner Code #
1. Public Land Survey	T 31N R 11W	I-4 (Leelanau)
	T R	
	T R	
	T R	
2. Property Controlling in Section	S T R	
	S T R	
3. Miscellaneous Property in Sec.	S T R	
	S T R

I-4: ¼ Corner Common to Sections 10 and 11:

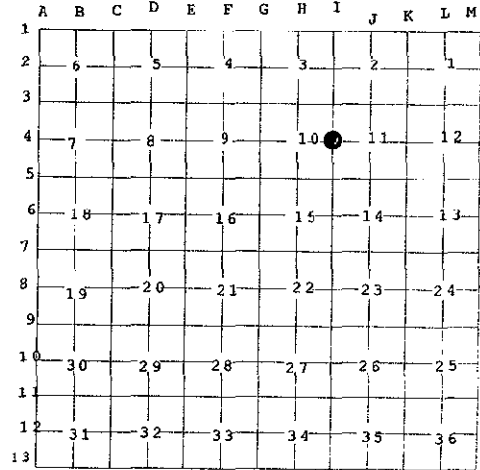
- Fd. ½" iron pipe 2.5' below road surface in centerline of Indian Beach Road 57' W. of old Railroad grade.

- Found ½" iron pipe accepted as a careful and faithful re-establishment of the position of the original corner by the Leelanau County Peer Group, November 30, 1999 and replaced with ¾" i.d. galvanized 36" long iron pipe with a stamped brass cap in a monument box.

- S31°E 39.33' Fd. Spike W. Face P. Pole
- N42°W 37.20' Fd. Spike SW. Face 6" Hemlock
- N05°W 58.93' Fd. Nail W. Face P. Pole 5" above ground
- N66°W 65.85' Fd. Nail S. Face 14" Hemlock
- S08°W 53.24' Fd. Spike E. Face Twin 6" Cedar
