**LAND CORNER RECORDATION CERTIFICATE
Filing Requirement of Act 74, Mich. P.A. 1970**

<u>Leelanau</u> (County)	Located In:	Corner Code #
1. Public Land Survey	T 31N R 11W	I-5 (Leelanau)
	T _____ R _____	_____
	T _____ R _____	_____
	T _____ R _____	_____
2. Property Controlling in Section	S _____ T _____ R _____	_____
	S _____ T _____ R _____	_____
3. Miscellaneous Property in Sec.	S _____ T _____ R _____	_____
	S _____ T _____ R _____	_____

I-5: Corner Common to Sections 10, 11, 14 and 15:

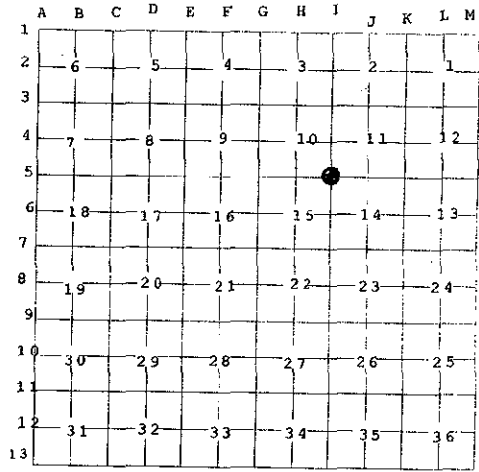
Fd. 3" x 36" iron pipe lying on ground from recent excavating near original position. Old standing fences N. and W.

Found 3" iron pipe accepted as a careful and faithful re-establishment of the position of the original corner by the Leelanau County Peer Group, November 30, 1999 and replaced with 3/4" i.d. galvanized 36" long iron pipe with a stamped brass cap.

- N80°W 5.47' Fd. Spike N. Face Blazed Twin 12" Maple
- S30°W 20.80' Fd. Bent Nail NW. Face 3" Ash
- S70°W 4.38' Fd. Nail SE. Face Blazed 5" Maple
- N64°E 79.42' Set Nail N. Face 14" Ash
- N69°E 98.78' Set Nail SE. Face 14" Maple
- S22°W 62.60' Set Nail SE. Face 12" Maple
