REMONUMENTATION

Filed under Remonumentation Act 345 of 1990
LAND CORNER RECORDATION CERTIFICATE
Filing Requirement of Act 74, Mich. P.A. 1970

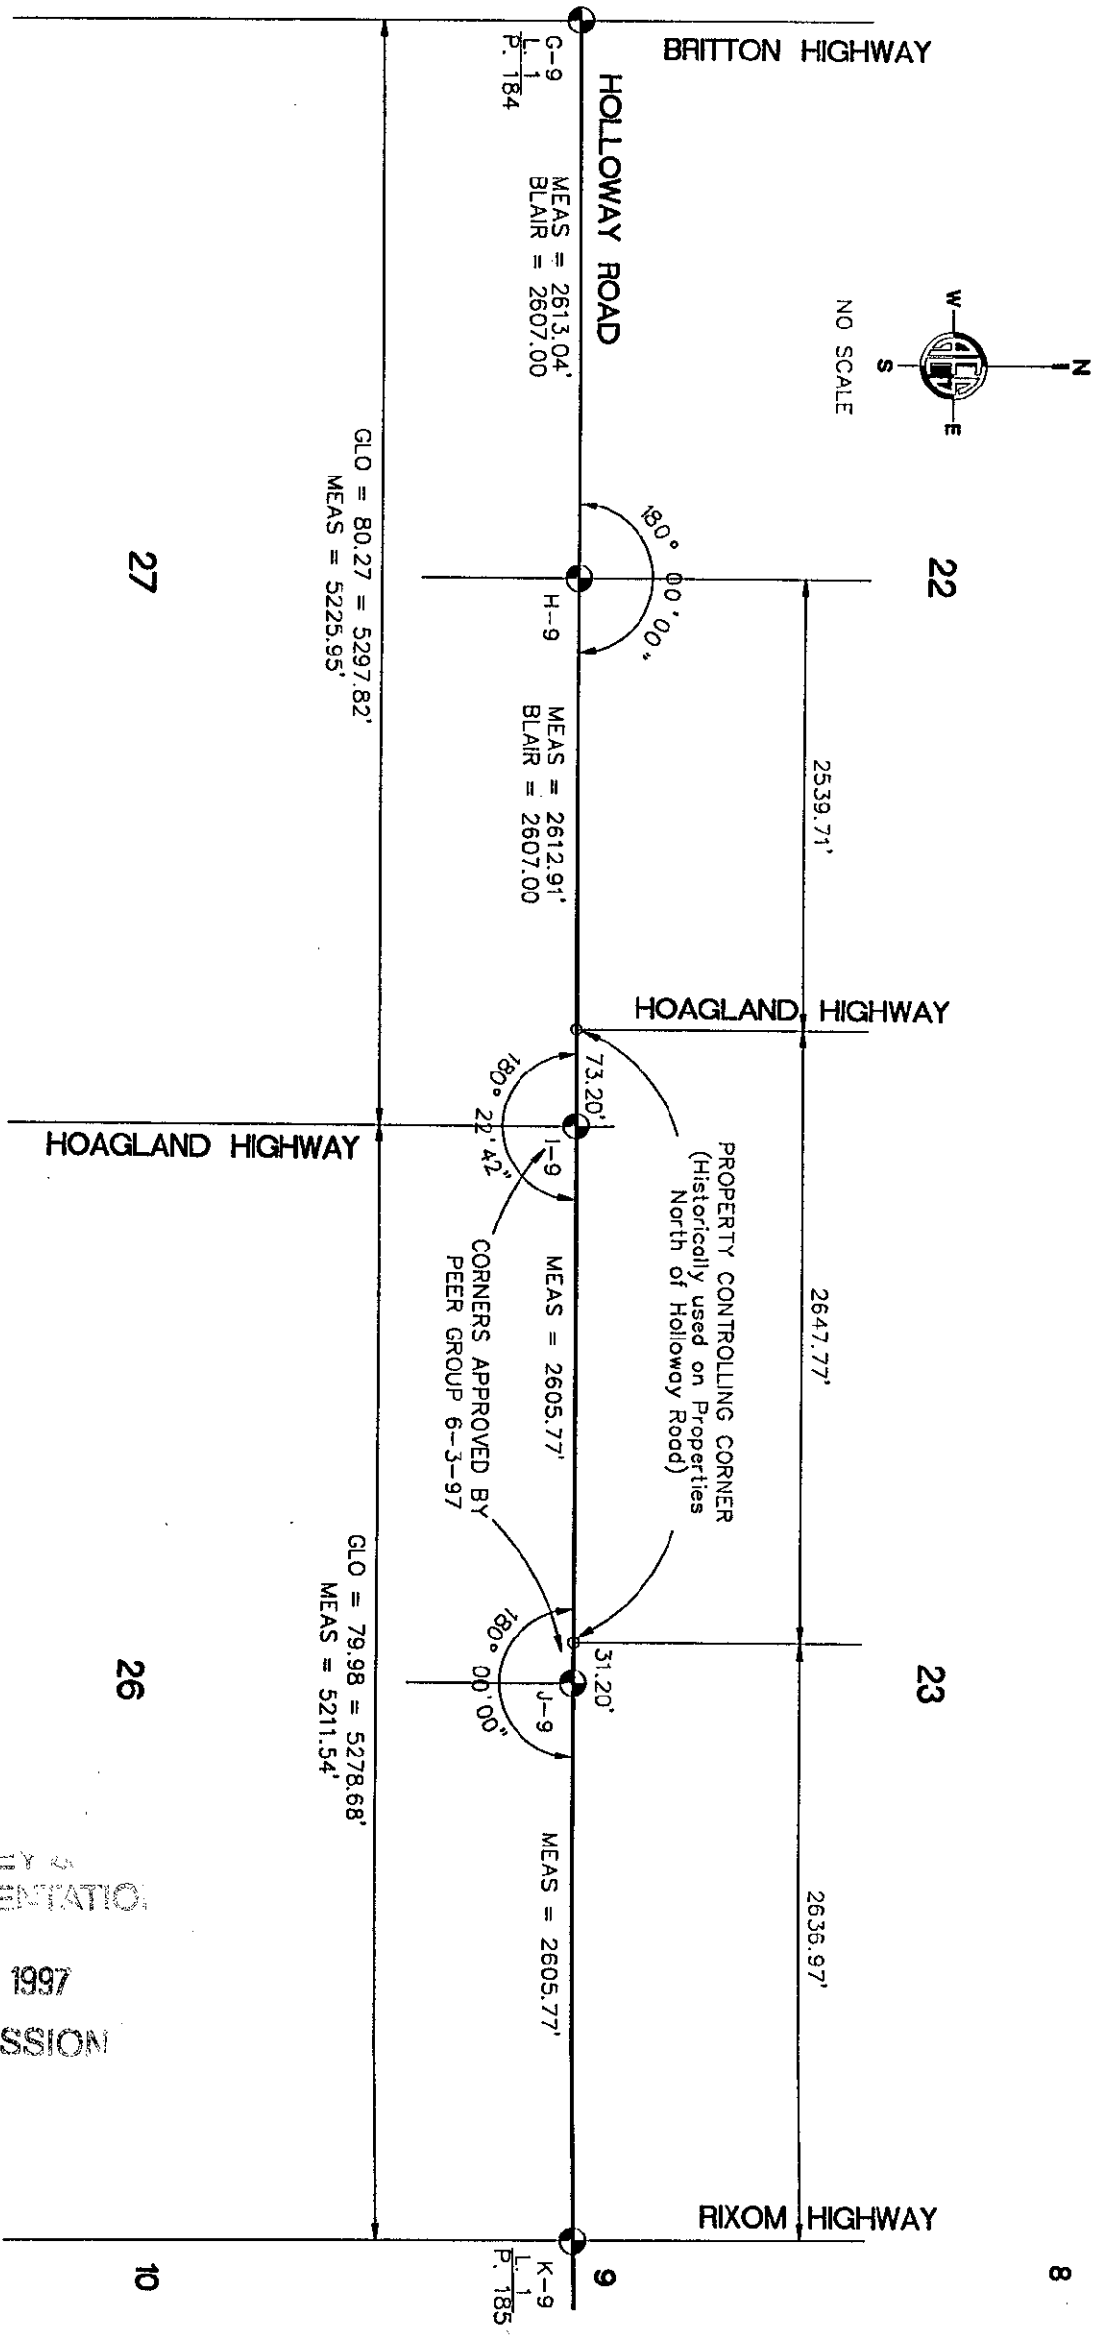
(See sketch on back)

27

22

G.L.O. notes 1819 Joseph Fletcher D.S. "set post, no bearings, wet prairie"
This corner was re-established with a stake by James Blair, County Surveyor on a survey made in Sept. 1881 using found corners at the NW cor of 27, the NE cor of 26 and the SE cor of Sec 27 and the 1/4 cor common to Sections 15 and 16? (14?)
I re-established the corner with an iron pipe on a survey I did in August 1974 by retracing Blairs survey and recorded it in L3, P 31
The Road Comm. had difficulty in obtaining additional R.O.W. on the south so they could move the road south to make a six foot wide shoulder along the deep ditch which runs along the North side of the road.
1993 Found iron pipe on south slope of deep drain but tipped to Northeast next to burrow of woodchuck.
Replaced the iron pipe with a 3/4" X 5' iron pipe by retracing the survey I had done of Sections 27 and 26.

6-30-97 Replaced the 3/4" X 5' iron pipe with a 30" Harrison monument
