STATE OF MICHIGAN
LENAWEE COUNTY
FILED

SURVEY OF
REMONUMENTATION

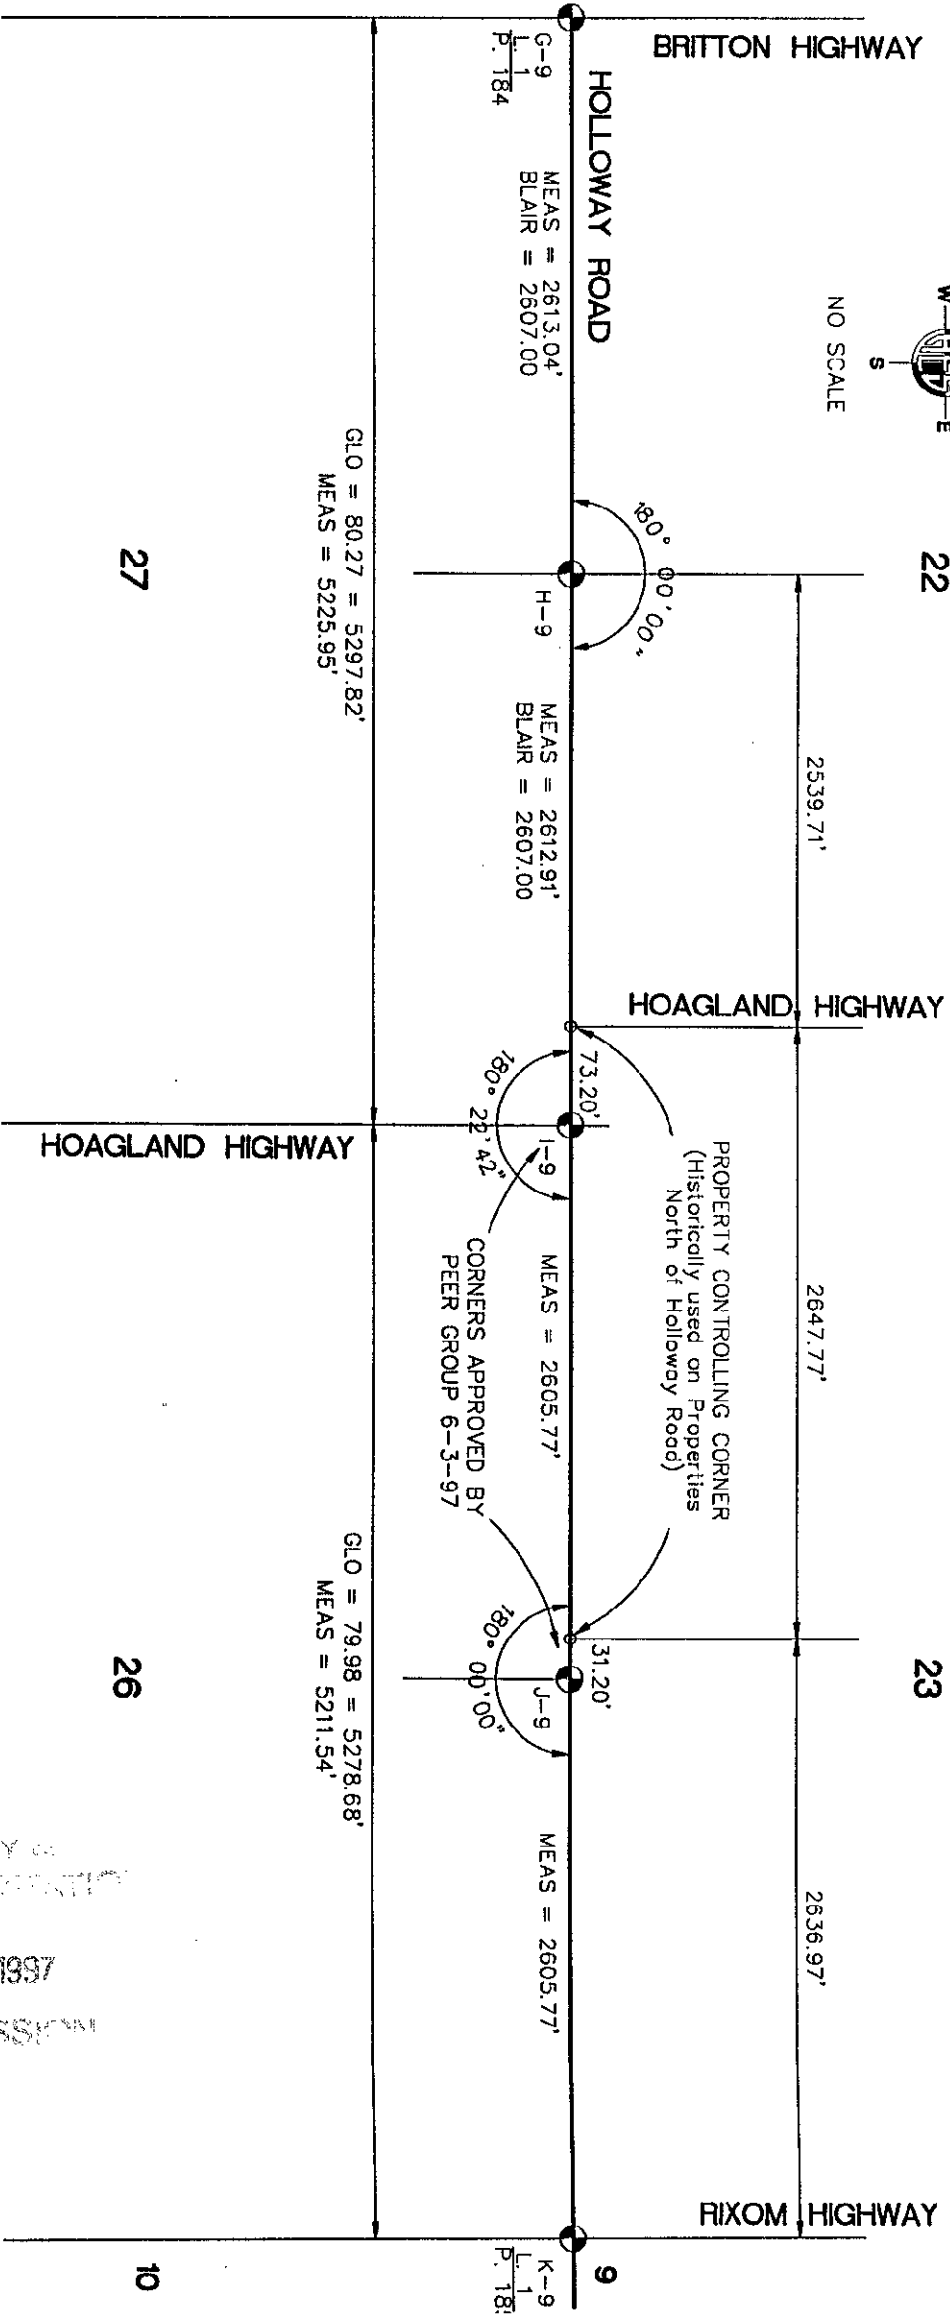
Found nail & washer in face of Elec pole S 75° W 126.94
Dbl hd nail & disc in Elec pole S 80° E 250.34
" X " cut on 12" CMP N 70° W 55.37
" X " cut on 12" CMP N 60° W 37.30
SW corner of house foundation N 75° W 247.17
SE corner of house foundation N 70° W 198.63

Property Controlling Corner (5/8" X 2' re-rod capped G.E.R. 13040 in pavement) for Section 23 West 31.20 on line between I-9 and J-9 T6S R5E as approved by the Peer Group on June 3, 1997.

(See sketch on back)
