SURVEY & REMONUMENTATION

LAND CORNER RECORDATION CERTIFICATEBER 1 PAGE 216

For corners in Lenawee (County)	Located In:	Corner Code #	STATE OF NICHIGAN LENAWEE COUNTY FILED
1. Public Land Survey	T <u>-8-S</u> R <u>-4-E</u> T R	A-3	17 OCT 97 3:57 P.M. VICTORIA J. DANIELS

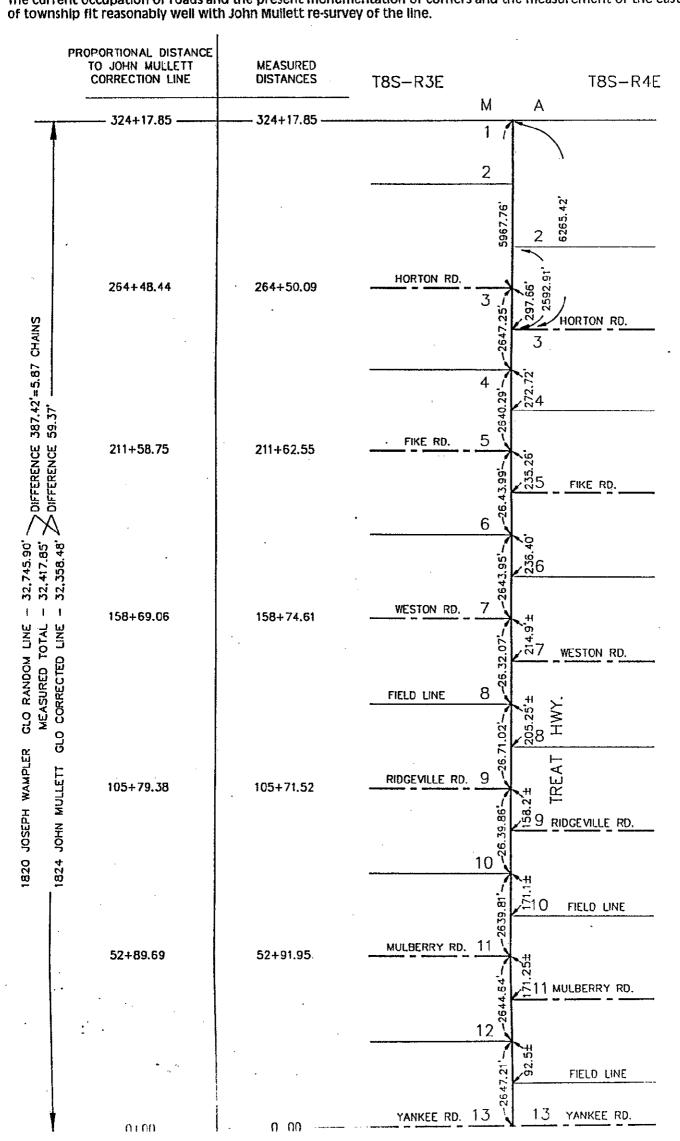
*NOTE: SEE COMMENTS & SKETCH ON BACK

October 8, 1997. Found re-rod under base course of new asphalt pavement. Drove 3/4" X 3' iron pipe capped G.E.R. 13040 over re-rod and set monument box. It is 297.66 South of M-3 T8S R3E and on line between M-3 and M-4 T8S R3E.

dbl. hd. nail & disc in guard rail post West 11.49

1819, Joseph Wampler surveyed the township line from North to South, apparently making an error of approximately 5 chains as he shows the last distance to be 96.15 chains and corrected all temporary corners 16.15 chains South.

1824, John Mullett re-surveyed and corrected this line surveying from South to North, calling out old corners and setting new corners at 40 chain intervals and shows the last distance as 90.28 chains for a difference of 5.87 chains. James Blair's 1880± records of each section show the jogs to be to the corrected corners set by John Mullett. The current occupation of roads and the present monumentation of corners and the measurement of the east line
