SURVEY & REMONUMENTATION

LAND CORNER RECORDATION CERTIFICATE

Filing Requirement of Act 74, Mich. P.A. 1970

STATE OF MICHIGAN LENANEE COUNTY

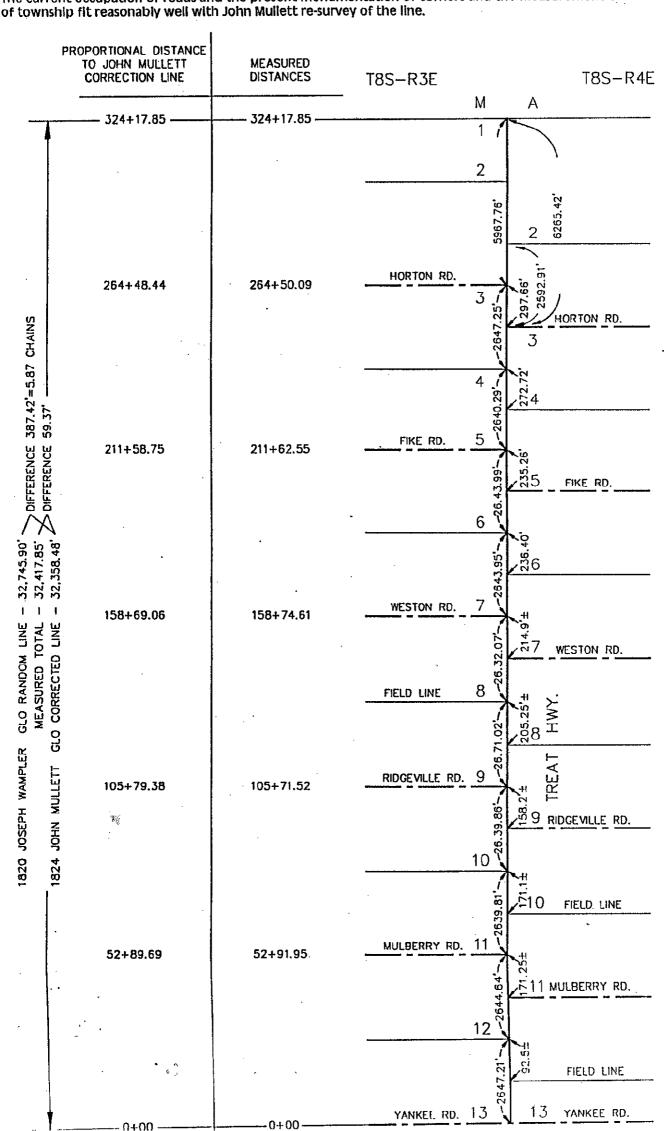
*NOTE: SEE COMMENTS & SKETCH ON BACK

1819, Joseph Wampler surveyed the township line from North to South, apparently making an error of approximately 5 chains as he shows the last distance to be 96.15 chains and corrected all temporary corners 16.15 chains South.

1824, John Mullett re-surveyed and corrected this line surveying from South to North, calling out old corners and setting new corners at 40 chain Intervals and shows the last distance as 90.28 chains for a difference of 5.87 chains. James Blair's 1880± records of each section show the jogs to be to the corrected corners set by John Mullett. The current occupation of roads and the present monumentation of corners and the measurement of the east line
