LAND CORNER RECORDATION CERTIFICATE
Filing Requirement of Act 74, Mich. P.A. 1970

Located In:	Corner Code #
1. Public Land Survey	T ___ R ___
	T ___ R ___
	T ___ R ___
	T ___ R ___
2. Property Controlling in Section	S 10 T 46N R 10W 11
	S 10 T 46N R 10W 14
3. Miscellaneous Property in Sec.	S ___ T ___ R ___
	S ___ T ___ R ___

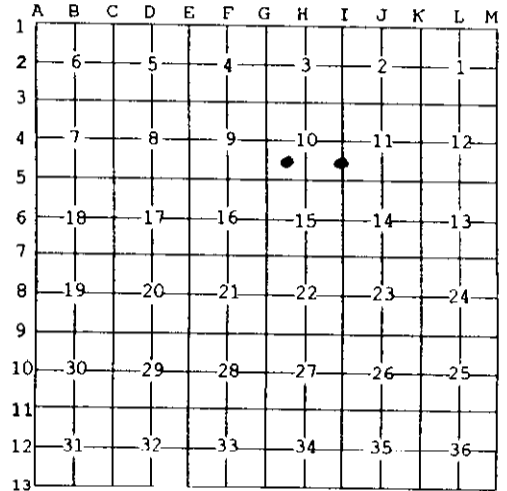
A. Description of original monument and accessories and/or subsequent restoration:
(11-Sec. 10) Southwest 1/16 corner, Section 10. Not established in the original survey. Found no subsequent record.
(14-Sec. 10) South 1/16 corner between Sections 10-11. Established in 1963 by Billy D. Buckler RLS midway and on line between Section Corner to South and intersection of road and fences for accepted 1/4 corner to North. Mr. Buckler squared a 3" Birch for the corner and made witnesses: 8" W. Birch S24W 22 links, 5" Aspen S15E 21 links.

(11-Sec. 10) Established the corner at the intersection of straight lines connecting opposite 1/16 corners.
(14-Sec. 10) Mr. Buckler's corner tree and witnesses were not recovered. Reestablished the corner midway and on a straight line between Section corner 1317.05' south and Quarter corner 1317.05' north.

(11) Set 1"IDx36" I.pipe with 4" alum. MDNR cap. Blazed, scribed, and set measuring nails in: 6" W.Spruce N12E 21.05' "SW1/16 BT" 5" W.Spruce N40W 29.15' do 6" Balsam S12E 17.7' do 6" R.Maple N82E 10.15' do Bearings are magnetic. Distances are to nail with tag.	(14) Set 1"IDx36" I.pipe with 4" alum. MDNR cap. Blazed, scribed, and set measuring nails in: 5" Balsam N80W 43.8' "S1/16 BT" 6" Aspen S28W 7.75' do 5" Aspen S66E 12.9' do 4" Aspen East 13.35' do Bearings are magnetic. Distances are to nail with tag.
--	---
