**LAND CORNER RECORDATION CERTIFICATE**  
**Filing Requirement of Act 74, Mich. P.A. 1970**

(H5) Quarter corner common to Sections 10-15. Corner reestablished in 1972 by Billy D. Buckler, RLS, midway and on a straight line between section corners. Corner monument: 1" pipe with 4" aluminum cap. Witnesses to corner: 14" W. Pine S07W 75.4', 16" R. Maple S42W 50.4'.  
 (15-Sec. 10) West 1/16 corner between Sections 10-15. Corner established in 1972 by Billy D. Buckler, RLS, midway and on a straight line between Section corner to west and 1/4 Corner to east. Corner monument: 1" pipe with 4" aluminum cap. Witnesses to corner: 12" W. Pine S18E 14.3', 14" W. Pine N15W 6.2'.

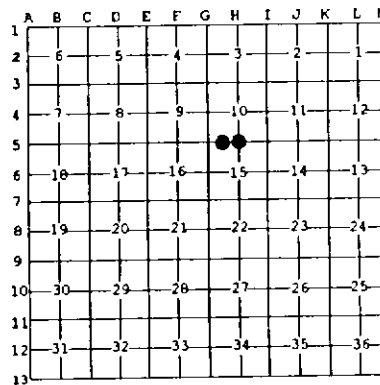
(H5) Found the 1972 monument as described, in good condition, and at record bearing and distance from the 1972 witness trees, both in good condition. Left the monument in place, made new BH marks on the 1972 trees, and marked two new accessories as described below. Corner recovered and re-witnessed by T. Stark and D. Lampela, Newberry District Office.  
 (15-Sec. 10) Found the 1972 monument as described, in good condition, and at record bearing and distance from the 1972 witness trees, both recovered in good condition. Determined the monument to be 0.27' West and 0.28' South of the position intended in 1972 and accepted the monument as a careful and faithful determination of the position of the corner. Left the monument in place, made new BH marks on the 1972 witness trees, and marked two new trees as described below. Corner recovered and re-witnessed by T. Stark and D. Lampela, Newberry District Office.

(H5) Found 1" iron pipe with 4" MDNR cap. Blazed, scribed, and set measuring nails in the following: 18" W. Pine S12W 75.6'    1/4S' 16" R. Maple S46W 50.8'    1/4S' 5" Balsam S37W 8.5'    1/4S NBT' 7" Balsam N04E 13.55'    1/4S NBT'	(15) Found 1" iron pipe with 4" MDNR cap. Blazed, scribed and set measuring nails in the following: 13" W. Pine S11E 14.3'    "W1/16" 16" W. Pine N08W 6.4'    "W1/16" 18" R. Pine N74E 35.95'    "W1/16 BT" 13" W. Pine S54E 29.7'    "W1/16 BT"
Placed a squared and scribed cedar post adjacent. Bearings are magnetic.	Placed a squared and scribed cedar post adjacent. Bearings are magnetic.
