**LAND CORNER RECORDATION CERTIFICATE**  
**Filing Requirement of Act 74, Mich. P.A. 1970**

Mackinac  
 (County)

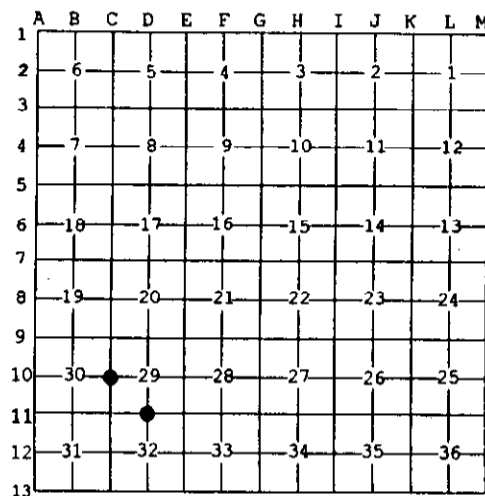
(D11) Quarter corner common to Sections 29-32. 1959 record of Billy D. Buckler RLS: This corner was reestablished midway and on line between two Section Corners. No evidence of original corner. Corner was placed and witnessed September 18, 1959 with Frank Gray. 1" pipe with 4" brass cap. 8" Beech S42E 55 links, 6" Twin Cedar S25W 83.5 links.  
 (C10) Quarter corner common to Sections 29-30. 1849: Established by Guy H. Carleton: North between 29 and 30...40.00 Set post for 1/4 section corner. Sugar 20 N70W 15 lks, Sugar 14 S61E 20 lks....80.00 set post for corner to sections 19-20-29-30.

(D11) The 1959 monument was not recovered. Found an old squared and scribed cedar post at substantial record bearing and distance from the remaining NBT twin Cedars and 3.6' east of the position of record. The Beech NBT is gone. Reestablished the corner midway and on a line of mean true bearing between Section corners of record 2642.76' east and west.  
 (C10) The original post and accessories were not recovered. Found no evidence of the position of the original corner on the ground. Reestablished the corner midway and on a line of mean true bearing between Section corners of record 2645.76' north and south.

(D11) Set 1"IDx36" I.pipe with 4" alum. MDNR cap. Blazed, scribed, and set measuring nails in: 12" twin Cedar S22W 54.15'    "1/4S" 12" Maple S59E 14.3'        "1/4S NBT" 10" Balsam N77E 30.9'        do 12" Maple S41W 66.1'        do Bearings are magnetic. Distances are to nail with tag.	(C10) Set 1"IDx36" I.pipe with 4" alum. MDNR cap. Blazed, scribed, and set measuring nails in: 12" Maple N45E 6.0'        "1/4S NBT" 10" W.Birch S46E 43.85'    do 8" Maple S03E 14.2'        do 12" Beech S31W 39.9'        do Set cedar post adjacent. Bearings are magnetic. Distances are to nail with tag.
---	--
