LAND CORNER RECORDATION CERTIFICATE
Filing Requirement of Act 74, Mich. P.A. 1970

For corners in
Mackinac

1. Public Land Survey	T	42N	R	12W	C6
	T	42N	R	12W	C5
	T		R		
	T		R		
2. Property Controlling in Section	S		T	R	
	S		T	R	
3. Miscellaneous	S		T	R	
Property in Sec.	S		T	R

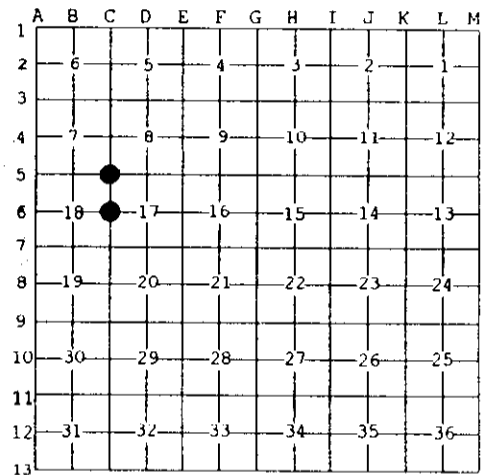
A. Description of original monument and accessories and/or subsequent restoration:
 (C6) Quarter corner common to Sections 17-18. 1969: Billy D. Buckler, RLS reestablished the corner midway and on line between Section corners. Set 1" iron pipe with 4" aluminum cap. 1985: the 1969 monument was recovered by G.L. Wiggins, RLS and witnessed with: 10" Cedar N44W 155.9', 12" Cedar N29W 166.3', 8" B.Ash N22W 125.4', 6" B.Ash S14E 23.3'.
 (C5) Corner common to Sections 7-8-17-18. 1969: Corner replaced by Billy D. Buckler, RLS from an original Cedar witness N87E 34 links. Set 1" pipe with 4" aluminum cap. 14" Soft Maple S40W 6.7', 12" Cedar N65W 17.6', 5" Cedar N87E 6.0'.

(C6) Recovered but did not accept the 1969 monument. I discovered that Mr. Buckler had made an arithmetic error in his 1969 calculations which led him to believe that the corner 1/2 mile north of this position, C5, was 100 feet further west than it actually was on the ground. Consequently, his proportionate position for this corner is erroneous. I reestablished the corner by single proportionate measurement to the original record between Section corners 2687.61' North and South. Removed the 1969 monument and destroyed the 1985 witness trees. The position for the corner falls in an 8" Balsam.
 (C5) The 1969 monument was not recovered. Monumented the corner at record bearing and distance from the 1969 witnesses. The Soft Maple and Cedar NE are in good condition. The Cedar NW is standing dead.

(C6) Set 5/8"x30" rebar, driven into an 8" Balsam stump cut 10" above ground, capped with a plas. cap stamped "MICH DNR PS 33986". Blazed, scribed, and set meas. nails in:	(C5) Set 1" IDx36" I. pipe with 4" alum. MONR cap. Blazed, scribed, and set measuring nails in:
5" Balsam S64W 2.25' "1/4S N8T"	8" Cedar N77W 12.2' "S7 N8T"
6" Balsam N61W 1.8' do	10" Cedar N28W 47.65' "S7 N8T"
8" Balsam N78E 8.05' do	20" Maple S40W 7.75' old blazes *
14" Spruce S52E 24.25' do	8" Cedar N82E 6.7' "S8" *
Bearings are magnetic.	Bearings are magnetic. Distances are to nail with tag. * denotes 1969 N8T.
