**SURVEY &
REMONUMENTATION**

LAND CORNER RECORDATION CERTIFICATE
Filing Requirement of Act 74, Mich. P.A. 1970
Mackinac County Remonumentation Corner

<u>Mackinac</u>	Located In:	Corner Code #
1. Public Land Survey	T <u>43N</u> R <u>1W</u>	<u>D-1</u>
	T ___ R ___	_____
	T ___ R ___	_____
	T ___ R ___	_____
2. Property Controlling in Section	S ___ T ___ R ___	
	S ___ T ___ R ___	
3. Miscellaneous Property in Sec.	S ___ T ___ R ___	
	S ___ T ___ R ___	
4. Lot No. _____, Recorded Plat _____		
5. Private Claims _____

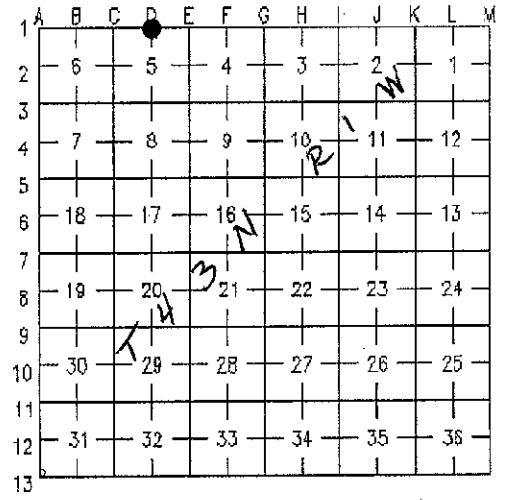
A. Description of original monument and accessories and/or subsequent restoration:
(D-1) North 1/4 corner of Section 5, Township 43 North, Range 1 West.
This corner was not set in the original G.L.O. survey. Found no evidence of corner position other than an existing fence on the East line of the "Cottle Cemetery" (the apparent North-South 1/4 line of Section 5). The standard South 1/4 corner of Section 32, Township 44 North, Range 1 West falls 10.8 feet West of cemetery fence - G.L.O. falling was 6.6 feet.

B. Description of corner evidence found and/or method applied in restoring or reestablishing corner:
(D-1) North 1/4 corner of Section 5, Township 43 North, Range 1 West.
This corner is being re-established as part of the Mackinac County Remonumentation Program. Corner position was re-established on line between the Southeast and Southwest corners of Section 32, Township 44 North, Range 1 West, and on the extension of the fenceline on the East side of "Cottle Cemetery". Corner was placed in a new monument box in the centerline of Townline Road (East-West, paved) and 10.8 feet East of the standard South 1/4 corner of Section 32, Township 44 North, Range 1 West.

C. Description of monument for corner and accessories established to perpetuate locating the position of the corner:
(D-1) North 1/4 corner of Section 5, Township 43 North, Range 1 West.
Corner is a 3/4" x 24" iron with plastic "County Remonumentation" cap inside a monument box in the centerline of Townline Road and the extension of the fenceline on the East side of "Cottle Cemetery".

Utility Pole (PD2/70/50)	N42°E	40:00 feet
Chiseled "X" in top of corner metal fence post	S07°W	33.33 feet
4" Spruce	S82°W	117.07 feet
Corner Fence Post	N10°W	49.53 feet
S 1/4 Corner Section 32	West	10.8 feet
