SURVEY & REMONUMENTATION

LAND CORNER RECORDATION CERTIFICATE
 Filing Requirement of Act 74, Mich. P.A. 1970
 Mackinac County Remonumentation Corner

A. Description of original monument and accessories and/or subsequent restoration:
(F-1) North 1/4 Corner of Section 4, Township 43 North, Range 1 West.

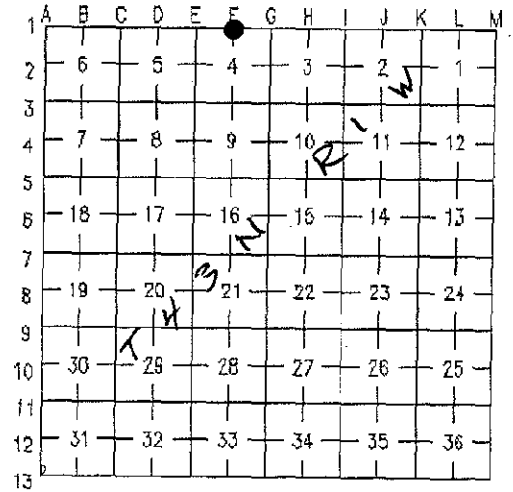
Corner is a 1/2" iron pin in monument box in centerline of Townline Road, on the extension of a fenceline to the South and 20.10 feet East of South 1/4 corner (iron in monument box) of Section 33, Township 44 North, Range 1 West.

Witnesses:		
Utility Pole (64)	N54°W	51.43 feet
Fence Post	S18°W	48.31 feet
Fence Post	S54°E	94.40 feet
Punch Hole in West End of C.M.P.	S08°E	42.52 feet
