**LAND CORNER RECORDATION CERTIFICATE**  
Filing Requirement of Act 74, Mich. P.A. 1970

Mackinac

T 44N R 10W

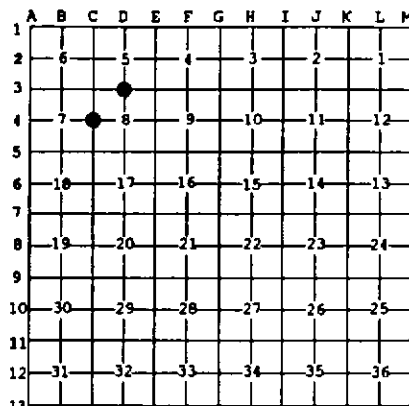
(C4) Quarter corner common to Sections 7-8. 1976 record by Billy D. Buckler, RLS: "Corner reestablished by single proportionate measure, between two Section Corners. Found no evidence of original corner. Placed 1" pipe with 4" aluminum cap at corner. New Bearings 5' Soft Maple N21W 33.0', 6' Soft Maple S12E 26.7'. Corner lies 13' North of an old RR grade".

(C4) Recovered the 1976 monument, a 1" ID iron pipe capped with a 4" dia. cast aluminum MDNR tablet, in good condition, and at record bearing and distance from the 1976 witness trees, both recovered in good condition. The RR grade has been pretty much obliterated by logging traffic. Left the monument in place, marked new top blazes on the 1976 trees, and marked two new accessories as described below. Corner recovered and re-witnessed by T. Stark, Newberry District Office.

(D3) Recovered the 1976 monument as described, a 1" ID iron pipe capped with a 4" dia. cast aluminum MDNR tablet, in good condition, and at record bearing and distance from the remaining witness Hemlock which is dead but standing. The cedar has been cut. Left the monument in place and marked four new accessories as described below. Corner recovered and re-witnessed by T. Stark, Newberry District Office.
