**SURVEY &
REMONUMENTATION**

PROVED LAND CORNER
P.A. 345 OF 1990
MIDLAND COUNTY

LAND CORNER RECORDATION CERTIFICATE
Filing Requirement of Act 74, Mich. P.A. 1970

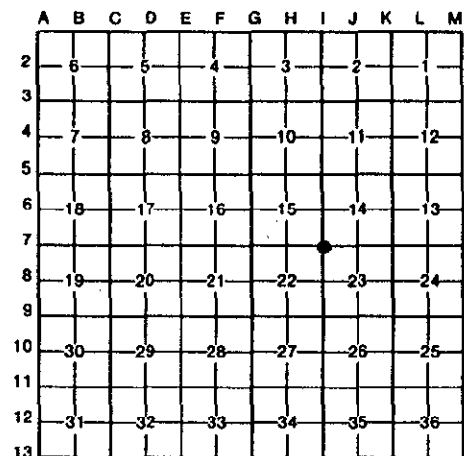
- 1-7: Corner common to Sections 14, 15, 22 and 23
1852 - Austin Burt, W. Pine 20" S 32°W, 52 lks, W. Pine 10" N 27°E, 60 lks
No C.S.R.
- 9-17-71 - John Meyers-P.B.L. (132) 1-15
1. N 20°W, 103.78' - Power Pole, 2. S 40°W, 62.25' - 8" Norway Pine
3. N 70°E, 67.40' - S.W. Cor. House, Corner is 26.06' North of R/W of U.S. Hwy 10
- 5-30-74 - Jerome Schafer Unrecorded Survey
Corner is 26.06' North of R/W of U.S. Hwy 10

- 1-7: Corner common to Sections 14, 15, 22 and 23
Found 1" x 14" Pipe. Excavated to depth of 3 feet. Did not find further evidence.
Found Recorded Witnesses #1 & 3, as noted above.

- 1-7: Corner common to Sections 14, 15, 22 and 23
Set 5/8" x 36" re-rod with brass cap stamped "Midland Co. Remon. Cor. PS 9433" in Mon. Box
N 20°W, 103.78' - Nail & Disk in Power Pole (1)
N 70°E, 67.40' - S.W. Corner of House (3)
S 30°W, 62.40' - Nail & Disk in 12" Red Pine
S 25°E, 85.41' - Nail & Disk in Power Pole
