SURVEY & REMONUMENTATION

**LAND CORNER RECORDATION CERTIFICATE
Filing Requirement of Act 74, Mich. P.A., 1970**

1997 G.B. Warnke Corner
Section corner to Sections 19, 20, 29 & 30 on Bunce Road in gravel surface

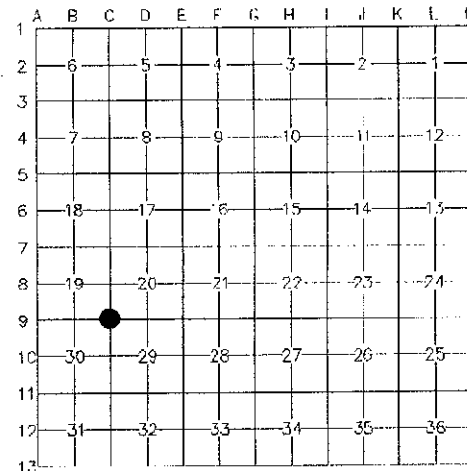
1" x 36" pipe with brass remonumentation cap replacing found railroad spike and is accepted as the best available evidence of the position of the original corner. Witnesses:

- East – 33.00' – found 1/2" pipe, 14" deep
- N 15° E - 126.80' – SW corner of east headwall
- N 20° W – 129.40' – SE corner of west headwall
- S 80° W – 30.5' – South end of 12" concrete culvert

On July 3, 1997, George B. Warnke field crew found railroad spike, 4" deep; dug 18" x 20" hole, but found nothing else (6" layer of stone then 6" sandy stone mix with clay). Replaced railroad spike with 1" x 36" iron pipe.
