LAND CORNER RECORDATION CERTIFICATE
Filing Requirement of Act 74, Mich. P.A. 1970

Marquette (County)	Located In:	Corner Code //
1. Public Land Survey	T 45N R 25W	D-1, E-1
	T R	
	T R	
	T R	
2. Property Controlling in Section	S 5 T 45N R 25W	1, 2
	S T R	
3. Miscellaneous Property in Sec.	S T R	
	S T R

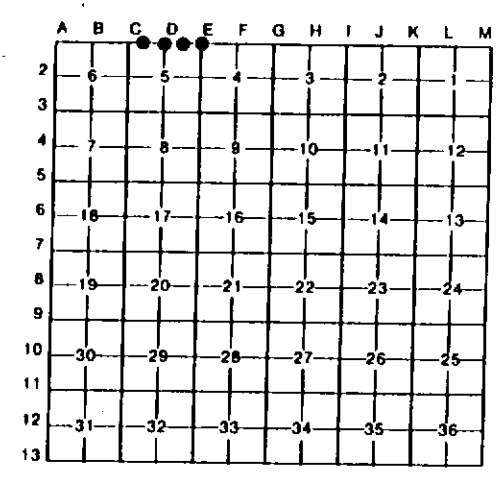
- D-1. No evidence of original survey or restoration found. Corner position re-established mid-point and on-line between the Northeast and Northwest corners of Section 5.
- E-1. Found 1" iron pipe and NBT's as described. Both NBT's dead but standing. Replaced iron pipe with DNR monument and witnessed.
 - 1. Corner position established mid-point and on-line between the Northwest and North Quarter corners of Section 5.
 - 2. Corner position established mid-point and on-line between the Northeast and North Quarter corners of Section 5. Corner falls about 40 feet east of the top of a rock knob.

- D-1. Quarter corner common to Sections 5 and 32. 1844: W.A. Burt, D.S. Set wood post witnessed by: Y.Birch 14 N81E 34 links; Y.Birch 22 N43W 14 links.
- E-1. Section corner common to Sections 4,5,32 and 33. 1942: Marquette County Road Commission. 1" iron pipe witnessed by: W.Pine 9 S15W 34.5'; W.Pine 8 N31W 8.9'.
 - 1. West One-sixteenth corner common to Sections 5 and 32. Not set in original survey, no evidence of subsequent establishment.
 - 2. East One-sixteenth corner common to Sections 5 and 32. Not set in original survey, no evidence of subsequent establishment.

D-1. DNR monument	E-1. DNR monument	1. DNR monument	2. DNR monument
6" Sugar N32E 19.0'	16" R.Pine N44E 37.9'	5" W.Spruce N43E 21.2'	6" W.Spruce N43E 24.3'
6" W.Spruce S51E 53.4'	8" R.Pine S26E 39.0'	5" tw.R.Maple S42E 6.1'	4" R.Maple S24E 27.3'
6" Sugar S73W 27.9'	8" J.Pine S10W 26.7'	8" R.Maple S70W 12.7'	5" R.Maple S45W 22.25'
6" W.Spruce N16W 26.25'	10" W.Pine S54W 44.6'	8" W.Birch N58W 24.9'	6" W.Spruce N15W 17.1'
