LAND CORNER RECORDATION CERTIFICATE
Filing Requirement of Act 74, Mich. P.A. 1970

Marquette <small>(County)</small>	Located In:	Corner Code //
1. Public Land Survey	T R	
	T R	
	T R	
	T R	
2. Property Controlling in Section	S 10 T 46N R 25W	4,8,10,11
	S T R	
3. Miscellaneous Property in Sec.	S T R	
	S T R

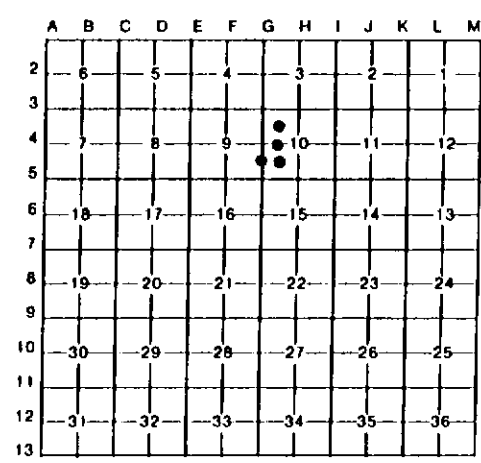
NOTE: Not more than 4 corners, all in the same town and range, may be recorded on this certificate.

- 4 Northwest one-sixteenth corner of Section 10. Not set in original survey, no evidence of subsequent establishment.
- 8 West one-sixteenth corner of Section 10. Not set in original survey, no evidence of subsequent establishment.
- 10 South one-sixteenth corner common to Sections 9 and 10. Not set in original survey, no evidence of subsequent establishment.
- 11 Southwest one-sixteenth corner of Section 10. Found 1" x 36" iron pin leaning against a tree.

- 4 Corner position established at the intersection of the north and west one-sixteenth lines of Section 10.
- 8 Corner position established at mid-point and on-line between the West Quarter and Center Quarter corners of Section 10.
- 10 Corner position established at mid-point and on-line between the Southwest and West Quarter corners of Section 10.
- 11 Found iron pin was not set in the ground and 130 feet south of monumented position. No witnesses were visible, and no other evidence was found indicating where it was placed. Corner position established at the intersection of the south and west one-sixteenth lines of Section 10.

4	DNR Mon.	8	DNR Mon	10	DNR Mon.	11	DNR Mon
8"	J.Pine N65E 28.85'	9"	J.Pine N81E 46.2'	9"	J.Pine N44E 13.25'	9"	J.Pine S89E 14.95'
7"	J.Pine S10E 33.35'	9"	J.Pine S50E 31.1'	5"	J.Pine S66E 59.9'	10"	J.Pine s04W 27.6'
9"	J.Pine S42W 36.65'	7"	J.Pine S28W 17.3'	5"	J.Pine S37W 10.25'	7"	J.Pine N88W 20.7'
7"	J.Pine N42W 44.25'	8"	J.Pine N55W 5.7'	5"	J.Pine N64W 23.6'	7"	J.Pine N04W 22.2'
