LAND CORNER RECORDATION CERTIFICATE
Filing Requirement of Act 74, Mich. P.A. 1970
AUG 26 PM 3:02

For corners in
Marquette
(County)

2. Property Controlling S 15 T 46N R 25W 8, 11, 15
in Section S T R

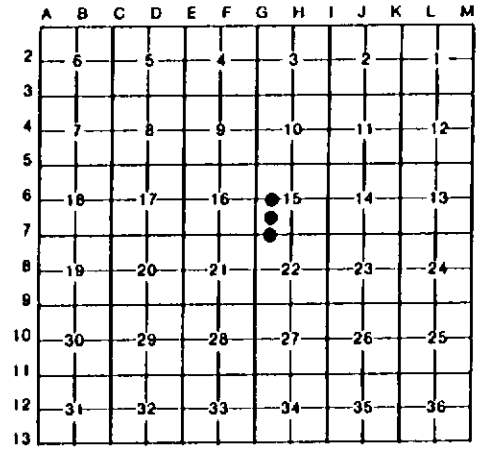
- A. Description of original monument and accessories and/or subsequent restoration:
- 8 West one-sixteenth corner of Section 15. Found 1" iron pipe set by local landowner.
 - 11 Southwest one-sixteenth corner of Section 15. Found 1/2" rebar with plastic cap by RLS 20711.
 - 15 West one-sixteenth corner common to Sections 15 and 22. Found 1/2" rebar with plastic cap by RLS 20711.

- B. Description of corner evidence found and/or method applied in restoring or reestablishing corner:
- 8 Rejected found iron pipe. Local landowner claims he put iron pipe in after logging had occurred. Corner position established mid-point and on-line between the West quarter and center quarter corners of Section 15.
 - 11 Accepted capped rebar as found as it falls 0.30 feet from calculated position.
 - 15 Accepted capped rebar as found as it falls 0.17 feet from calculated position.
