LAND CORNER RECORDATION CERTIFICATE
Filing Requirement of Act 74, Mich. P.A. 1970

Table with columns: Marquette (County), Located In, Corner Code //
1. Public Land Survey T 50N R 27W J-3, J-4, K-3, K-4
2. Property Controlling in Section S T R
3. Miscellaneous Property in Sec. S T R
4. Lot No. , Recorded Plat
5. Private Claims

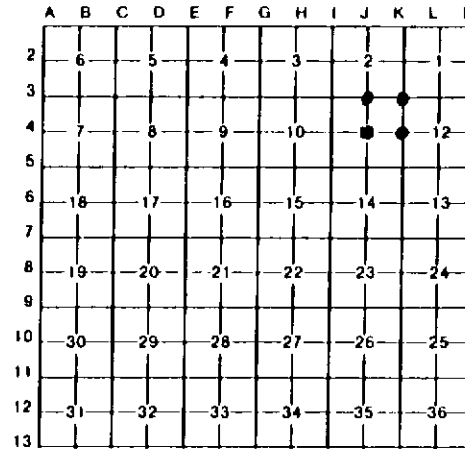
A. Description of original monument and accessories and/or subsequent restoration.

- J-3. Quarter Corner common to Sections 2 and 11. 1852: Abner B. Wood, D.S. Set wood post witnessed by: Hemlock 12 N69W 151ks.; Cedar 14 N43E 21 lks. 1940's: Marquette Co. Rd. Comm. records indicate a pine post witnessed by: Poplar 7 S70E 21.3'; Poplar 7 N24E 15.7'.
J-4. Center Quarter Corner of Section 11. Not set in original survey, no evidence of subsequent establishment.
K-3. Section Corner common to Sections 1,2,11 and 12. 1940: Marquette Co. Rd. Comm. Set 3/4" iron pin from OBT witnessed by: Hemlock 10 S11W 25.5'; W.Birch 5 N31E 28.1'.
K-4. Quarter Corner common to Sections 11 and 12. 1852: Abner B. Wood, D.S. Set wood post witnessed by: Sugar 10 N30W 13 lks.; Sugar 16 S54E 15 lks. Found 1" iron pipe and location poster, iron pipe not of record.

B. Description of corner evidence found and/or method applied in restoring or reestablishing corner:

- J-3. Found 1" iron pipe and MCRC witnesses as described. Both witnesses are dead. Found down cedar stub and a burned out stump in proper positions for OBT's. Replaced iron pipe with DNR monument and witnessed.
J-4. Corner position established at the intersection of the N-S and E-W quarter lines of Section 11.
K-3. Found iron pin and witnesses as described. Remains of OBT still evident (Cedar 12 N18W 10 lks) but no markings found. Replaced iron pin with DNR monument and witnessed.
K-4. No evidence of original survey found. Accepted found iron pipe as corner. Pipe is 5.89' off a straight line and five feet off of a split. Distances match well with the north line of Section 11.
