SECTION \_\_\_\_\_ LAND CORNER RECORDATION CERTIFICATE  
Filing Requirement of Act 74, Mich. P.A. 1970

MENOMINEE (County)	Located In:	Corner Code #
1. Public Land Survey	T <u>32</u> N R <u>26</u> W	B-03
	T _____ R _____	_____
	T _____ R _____	_____
	T _____ R _____	_____
2. Property Controlling in Section	S _____ T _____ R _____	_____
	S _____ T _____ R _____	_____
3. Miscellaneous Property in Sec.	S _____ T _____ R _____	_____
	S _____ T _____ R _____	_____

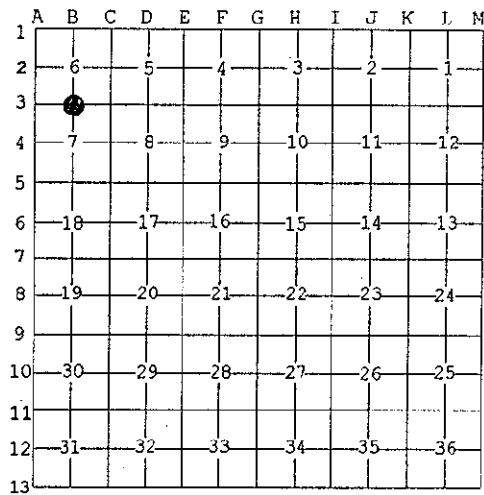
We recovered a 1/2" x 19" iron pin 1 foot north of the centerline of an East - West County Road and at a distance of 2636.24 feet East from the Northwest Corner of Section 7, T32N-R26W. The corner position matches well with other lot corners recovered from Robert Olsen's 1963 survey and with corners recovered from George Wilson's 1971 survey. This corner has been continuously used by local surveyors for at least 35 years, and is accepted as the best available evidence of the position of the original corner.

Set 5/8" x 24" Iron Rod/3-1/4" dia. Alum. cap stamped for corner location in Monument Box:

S.W. Cor. House Foundation	N18°E	65.90 feet	
5/8" x 24" Iron Rod/2" dia. Alum. Cap marked "WITNESS MARKER"	South	28.53 feet	
5/8" x 24" Iron Rod/2" dia. Alum. Cap marked "WITNESS MARKER"	S78°W	98.61 feet	0.5' South of P.P.
5/8" x 24" Iron Rod/2" dia. Alum. Cap marked "WITNESS MARKER"	N56°W	64.42 feet	0.5' East of P.P.
Metal Survey Sign Post	South	29.0 feet
