LAND CORNER RECORDATION CERTIFICATE
Filing Requirement of Act 74, Mich. P.A. 1970

| <u>MENOMINEE</u> (County) | Located In: | Corner Code # |
| 1. Public Land Survey | T <u>13N</u> R <u>27W</u> | <u>E02</u> |

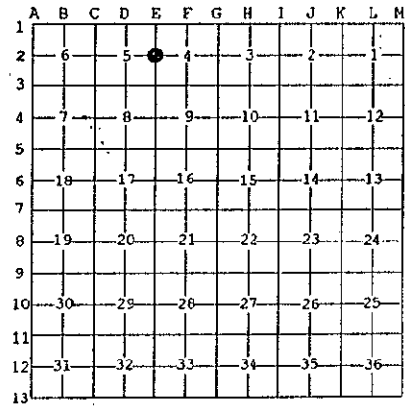
A. Description of original monument and accessories and/or subsequent restoration:

- 1848: Original Survey by John Mullett - B.T.'s - Beech, 3" - S11°W - 04 lks; Elm, 3" - N19°E - 16 lks. All original evidence for this corner has been destroyed by county road improvements.
- 1981: L.C.R.C. No. 296, recorded by George B. Wilson, RLS No. 17607, states "Re-set using old fence line North and South of Corner - Set 1/2" dia. iron pin, 6" below gravel road surface - TIES: 7" Cedar - 215° azm - 25.6'; 8" Cedar - 155° azm - 19.9'

B. Description of corner evidence found and/or method applied in restoring or reestablishing corner:

We recovered a 1/2 inch diameter iron rod and 2 B.T.'s as described in L.C.R.C. No. 296. This corner has been used by local surveyors for 15 years as a point of control for surveys and descriptions, and is accepted as the best available evidence of the position of the original corner.
