LAND CORNER RECORDATION CERTIFICATE
Filing Requirement of Act 74, Mich. P.A. 1970

1. Public Land Survey	T <u>34</u> N R <u>27</u> W	G-08
	T ___ R ___	_____
	T ___ R ___	_____
	T ___ R ___	_____
2. Property Controlling in Section	S ___ T ___ R ___	_____
	S ___ T ___ R ___	_____
3. Miscellaneous Property in Sec.	S ___ T ___ R ___	_____
	S ___ T ___ R ___	_____

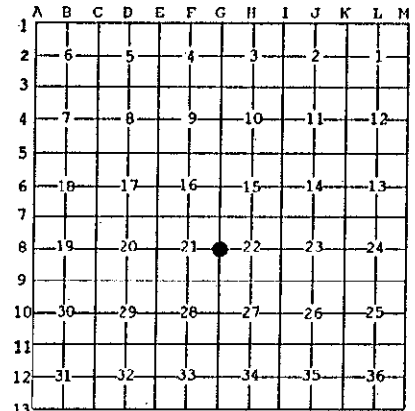
A. Description of original monument and accessories and/or subsequent restoration:

- 1848: Original Survey by James H. Mullett - B.T.'s - W. Pine, 12" - West - 07 lks.; W. Pine, 12" - S20°E - 39 lks. All original evidence for this corner has been destroyed by county road improvements.
- 1900: Survey by Albert Hass states "Set 4" Cedar Post from Government B.T."
- 1977: L.C.R.C. No. 168 by G.B. Wilson says - Found old iron pin in road, checks very well with survey done by Albert Hass in 1900. Set 1/2" dia. iron pin in pavement, tied into certified survey in SW1/4 - NW1/4.

B. Description of corner evidence found and/or method applied in restoring or reestablishing corner:

In a 1990 survey in Section 22, we recovered a bent 1/2 inch diameter iron pin in the centerline intersection of county roads East - West and North and in line with an ancient fence to the South. We replaced the bent iron with a Railroad Spike. We recovered the railroad spike in our 1997 remonumentation survey. This position matches with existing monumentation from several Certified Surveys in the area, and is accepted as the best available evidence of the position of the original corner.
