SURVEY & REMONUMENTATION

LAND CORNER RECORDATION CERTIFICATE
Filing Requirement of Act 74, Mich. P.A. 1970

| 1. Public Land Survey | T <u>35</u> N R <u>26</u> W | <u>G-11</u> |

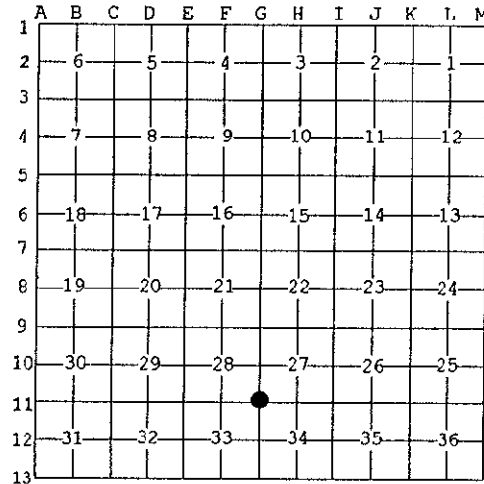
A. Description of original monument and accessories and/or subsequent restoration:

- 1848: Original Survey by James H. Mullett - B.T.'s - Hemlock, 12" - N42°E - 12 lks.; Cedar, 10" - S13°E - 18 lks. All original evidence for this corner has been destroyed by County Road improvements.
1975: L.C.R.C. No. 119, Book 1, by David B. Babbitt, RLS No. 21558 states "Set 1" pipe, 4" alum. cap in line with fences south and east and in line with centerline roads north and west." TIES: Cedar 10", N45°W, 41.0'; Cedar 5", N72°E, 54.8'; Corner fence post, south, 35.5'.

B. Description of corner evidence found and/or method applied in restoring or reestablishing corner:

The corner monument described in L.C.R.C. No. 119, Book 1 has been destroyed by County Road improvements, along with the Cedar B.T. - N72°E, 54.8 feet and the corner fence post South, 35.5 feet. We re-established David Babbitt's corner position based on an extensive DNR traverse which had ties to several corners in the SE Quadrant of T35N-R26W. This position checks well with the remaining B.T. - Cedar 10", N45°W - 41.0 feet. This position has been used for control in surveys in the area, fits well with long standing lines of occupation, and is accepted as the best available evidence of the position of the original corner.
