LAND CORNER RECORDATION CERTIFICATE
 Filing Requirement of Act 74, Mich. P.A. 1970

<u>MENOMINEE</u> (County)	Located in:	Corner Code #
1. Public Land Survey	<u>T_{37N} R_{27W}</u>	<u>G-5</u>
	T _____ R _____	_____
	T _____ R _____	_____
	T _____ R _____	_____
2. Property Controlling in Section	S _____ T _____ R _____	_____
	S _____ T _____ R _____	_____
3. Miscellaneous Property in Sec.	S _____ T _____ R _____	_____
	S _____ T _____ R _____	_____

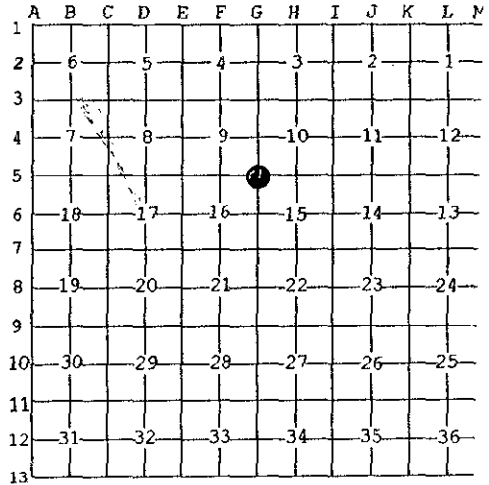
We recovered a 1-1/4" diameter Axle Shaft and the points of the 2 fence post ties as noted in part "A" above. The corner falls in line with the centerline of a county road running North and 5 feet South of the centerline of a county road running East. This corner has been accepted and used as the corner position by surveyors and local residents for over 40 years, and is accepted as the best available evidence of the position of the original corner.
