LAND CORNER RECORDATION CERTIFICATE
Filing Requirement of Act 74, Mich. P.A. 1970

<u>MENOMINEE</u> (County)	Located In:	Corner Code #
1. Public Land Survey	T <u>37N</u> R <u>27W</u>	<u>16</u>
	T ___ R ___	___
	T ___ R ___	___
2. Property Controlling in Section	S ___ T ___ R ___	___
	S ___ T ___ R ___	___
3. Miscellaneous Property in Sec.	S ___ T ___ R ___	___
	S ___ T ___ R ___	___

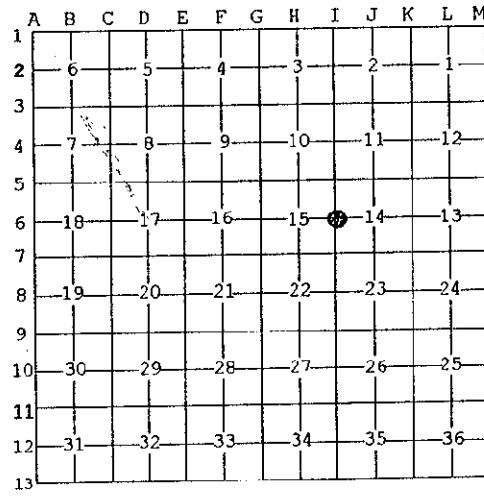
10" dia. Cedar	N41°E	44.27 feet	Scr. NBT
10" dia. Cedar	S45°E	36.38 feet	Scr. NBT
14" dia. Cedar	S28°W	24.44 feet	Scr. NBT
12" dia. Cedar	N65°W	28.94 feet	Scr. NBT
Metal Survey Sign Post	S10°W	1.0 feet

NOTE: All bearings are magnetic bearings. All distances are measured with steel tape. Distances to trees are to nail in side of tree.

B. Description of corner evidence found and/or method applied in restoring or reestablishing corner:
We computed the single proportional position for this corner and searched the area. The corner position falls in a cut over Cedar Swamp with no original evidence apparent and no occupational evidence. The land on both sides of the Section Line running between Sections 14 and 15 has been owned for many years by the same family. We set the corner at the single proportional position and accepted this location as a careful and faithful reestablishment of the position of the original corner.
