LAND CORNER RECORDATION CERTIFICATE

1. Public Land Survey	T	<u>23N</u>	R	<u>7W</u>	<u>C5</u>
	T	_____	R	_____	_____
2. Property Controlling in Section	S	_____	R	_____	_____
	S	_____	R	_____	_____
3. Miscellaneous Property in Section	S	_____	R	_____	_____
	S	_____	R	_____	_____

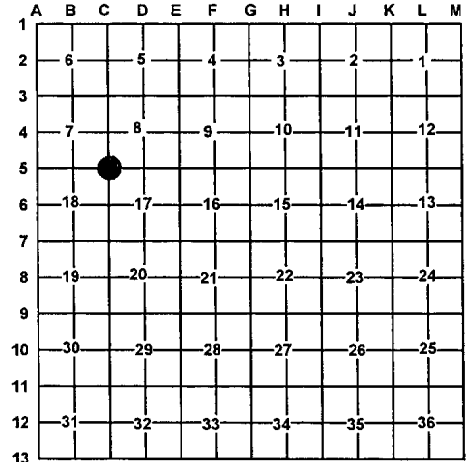
C5 – Section corner common to Sections 7,8,17 & 18, T23N, R7W - Found 1/2" x 24" long smooth iron rod with steel fence post alongside per Wilcox and record surveys. No GLO evidence found. Witnesses 4 & 10 are gone. Wilcox notes do not indicate how this 1/2" iron's position was established. 1/2" iron doesn't appear to have been established by double proportion. N46° E 59' (43± E and 40± N) from 1/2" iron a fence corner for fence remains N & E was found. 3 old cedar corner posts are at this fence corner indicating it had been perpetuated several times. This fence corner appears to have been built as a ROW corner for a road E & N that was never built. This fence corner could be E. A. Beuthien's Witness #5. Dug at Beuthien's record bearing and distance from fence corner but no evidence of stake or monument was found. Also dug area 33'S & 33'W of fence corner but nothing was found. From 1/2" iron measured grid distance and bearing of S88°24'02"E 2644.44' (2636.7' – GLO, 2633.40' – EAB) to 'D5' and N88°28'04"W 2644.94' (2640' – GLO) to 'B5'. Without conclusive evidence of another corner position and the monumentation and occupation based on the 1/2" iron since 1974, it is in the public's best interest to accept the existing 1/2" iron as the best available evidence of the position of the accepted corner.

C5 – Replaced 1/2" x 24" iron rod with stamped 4" DNR Alum. Cap on 1" x 36" galv. iron pipe. Add Blue Carsonite post 1' NW. Reset steel fence post 1' South. Reset steel sign post 1' East

- N8° E 39.42' to set N & T in E. side 7" W. Pine
- S62° E 29.09' to fd. nail in N. side Triple 11", 14" and 10" R. Maple (#8)
- S43° W 25.98' to set N & T at fd. Nail and Cap in NW side 8" W. Birch Clp. – 4 (#6)
- S74° W 24.05' to set N & T at fd. Nail & Cap in N. side 12" W. Birch (#7)
- N55° W 13.04' to set N & T at fd. nail in N. side 16" Oak (#11)
