SURVEY & REMONUMENTATION

LAND CORNER RECORDATION CERTIFICATE

For corners in Oakland (County)

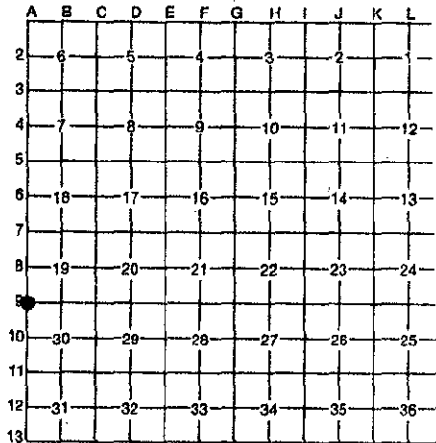
Recovered a boat spike in monument box in the centerline of Grange Hall Road. The spike and box are located 29 ft east of the concrete bridge overpass over the I-75 freeway. A tree/fence line runs north and a tree line runs south from the corner.

- N 51°W 33.73' NE corner north conc. guard rail (D)
S 34°E 32.85' PK nail NE power pole (C,D)
S 59°W 36.45' SE corner south conc. guard rail (D)
West 28.95' E edge conc. bridge deck (D)
N 45°W 22.23' SE cor. CB (B)
S 45°W 22.50' NE cor. CB (B)

- Set 5/8" rerod with O.C. remonumentation brass cap 0.19' west of boat spike in existing monument box.
N 45°W 32.38' PK/remon tag top guard rail post
N 45°E 28.03' PK/remon tag top guard rail post
S 45°E 27.40' PK/remon tag top guard rail post
S 35°E 32.70' PK/remon tag W. DE pole
S 45°W 32.73' PK/remon tag top guard rail post
