**SURVEY & REMONUMENTATION**

**LAND CORNER RECORDATION CERTIFICATE**  
Filing Requirement of Act 74, Mich. P.A. 1970

| M-1 NE CORNER SECTION 1 | T15N, R18W | GOLDEN TOWNSHIP |
| A-1 NW COR, SECTION 6 | T15N, R17W | HART TOWNSHIP |

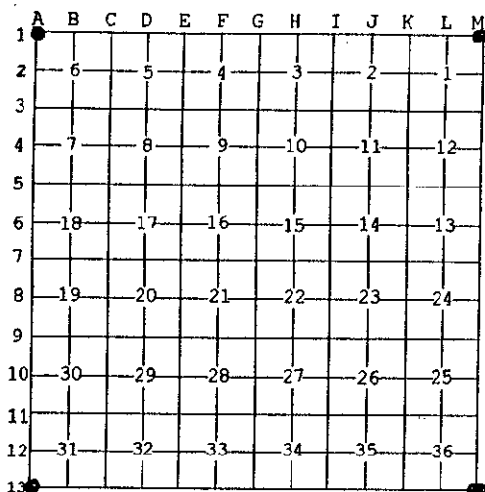
**A. Description of original monument and accessories and/or subsequent restoration:**

- GLO SET POST Intersected Range line at Temporary 6 mile post & Set Post Cor to Towns 15 & 16 North Range 17 & 18 West  
24" Pine N46°W 21' 10" Hemlock N64°E 9'  
Stream Call 13' wide course NE S 25.5'  
Stream Call 3' wide course NW E 16.6'  
Stream Call 13' wide course N E 5.5'

I found an old, smooth 1/2" Iron at the surface of the ground. I did not see any sheet metal on north side. All MDOT witnesses are standing and measure OK; Except the 3" W Pine is a 12" Pine with MDSH nail & tag plainly visible. Upon excavation the 1/2" Iron was found to be 40" long and is well-rusted. This iron has every appearance of being a John Bean, circa 1880, iron as it is typical of all other Bean irons that I have found. Although I have no historical record that Bean established this corner, I believe that it is nonetheless a John Bean iron. I also found a well-rotted fence post about 12" to the east.

I accept the 1/2" Iron as a careful and faithful perpetuation of the position of the original corner. No evidence is known to me that would lead me to believe that the corner should be at another location.

Set 4"x20" Harrison Cast Iron Monument, stamped "County Surveyor" and "26457" above the Iron which was driven down.
