LAND CORNER RECORDATION CERTIFICATE
Filing Requirement of Act 74, Mich. P.A. 1970

<u>Osceola</u> (County)	Located In:	Corner Code #
1. Public Land Survey	T <u>17N</u> R <u>8W</u>	<u>C-3</u>
2. Property Controlling in Section	S <u> </u> T <u> </u> R <u> </u>	<u> </u>
3. Miscellaneous Property in Sec.	S <u> </u> T <u> </u> R <u> </u>	<u> </u>

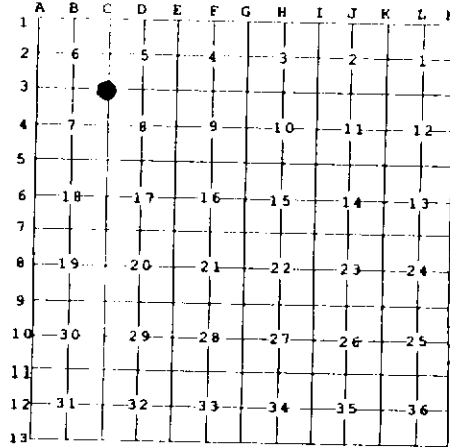
- C-3 - Section corner common to Secs. 5, 6, 7, 8, T17N, R8W. FND. Osceola Co. Brass cap on 1" pipe - down 0.8'. Dig down 1.5' and found 1 1/4" iron rod and wood stake 0.55' S. Dig down 1.9' and found old stake on S. side of pipe and tile, broken around pipe. Osceola Co. Mon. in tile accepted as a careful and faithful perpetuation of the position of original corner.

- C-3 - Osceola Co. Brass Cap on 1" pipe in tile.
 Add ring of stone with conc. around brass cap.
 N35°W 57.84' to Set N&T in NE Side Anchor Post. (JG)
 N17°E 82.04' to N&T in E. Side 10" Poplar Clp. (4).
 S12°W 55.28' Set 1/2" x 24" Rebar.
 S64°E 40.06' Set 1/2" x 24" Rebar.
 Corner in centerline intersection of gravel roads N-S-E & W.
