LAND CORNER RECORDATION CERTIFICATE
Filing Requirement of Act 74, Mich. P.A. 1970

<u>Osceola</u> (County)	Located In:	Corner Code #
1. Public Land Survey	T <u>17N</u> R <u>9W</u>	<u>K-3</u>
	T _____ R _____	_____
	T _____ R _____	_____
2. Property Controlling in Section	S _____ T _____ R _____	_____
	S _____ T _____ R _____	_____
3. Miscellaneous Property in Sec.	S _____ T _____ R _____	_____
	S _____ T _____ R _____	_____

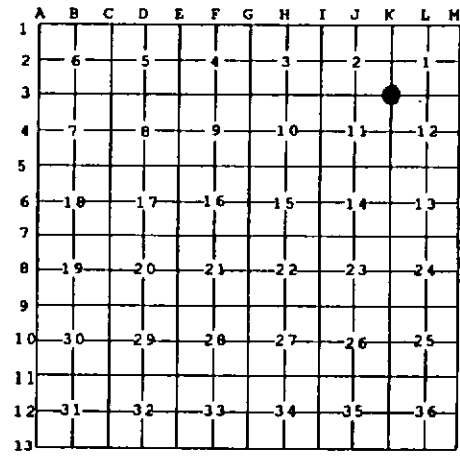
- K-3 - Sec. Cor. Common to Sec. 1, 2, 11 & 12 - FND. 3/4" x 3' long bent iron rod in 4" O.D. Vit. clay tile w/cinders per F. McClung and LCRC's and record surveys till 1979. MDNR Mon & Post had been moved. The Mon. accepted the best available evidence of the position of the original corner.
- Reference Pt 'A' - FND. MDNR Mon. & Cedar Post - N 4° 19' E 13.13' of K3. Monument was facing W & up against post, not MDNR procedure. Monument agrees with Rec. Survey L. 479 P. 119-121 witnesses. Monument was apparently moved between 1979 and 1987. 2 of the witnesses on this Rec. Survey are the same BT's as LCRC L.2, P. 11 but different dimensions. Remove MDNR Mon & Cedar post and replace w/ 1/2" x 24" Rebar. Monument established using improper procedures and is not utilized as K3 in this survey.

- K-3 - Replace bent 3/4" x 3' Iron Rod w/4" MDNR Alum Cap on 1" x 60" Iron Pipe - Up 1'. Place ring of stone & Boulders around. Reset cedar post to N., straighten 3/4" x 3' Iron Rod and drive down along W. side of Tile as memorial.
N 2°W 21.98' to Set Cabin Spike in CL. Rotten Remains 6" Maple Stp. (KJO)
N25°E 29.26' to Set N&T in NW Side 14" Twin W. Oak (KJO, FM, MM, RLW)
S25°E 20.03' to Set N&T in W Side 10" R. Oak (KJO, RLW)
N82°W 20.5' to Rotten Remains 8" +/- Maple Stp. (FM, MM)
N85°E 88.64' to N&T in N. Side 12" W. Oak scribed 'XBT'
S 65°W 63.51' to N&T in N. Side 8" W. Oak
N 60°W 52.19' to N&T in SW Side 3" W. Oak
N 4° 19' E +/- 13.13' to 1/2" x 24" Rebar being Reference Pt 'A'
