## OTTAWA COUNTY REMONUMENTATION

LAND CORNER RECORDATION CERTIFICATE

SECTION	Filing Requirement of Act 74, Mich. P.A. 19	70 B DOM		
For corners in OTTAWA Located in:	Corner Code#	REGISTER OF DEEDS OTTAMA OFFICE MI		
1. Public Land Survey T <sup>5N</sup> T	B-1 (N 1/4 Corner Sec. 6, Jamestown Twp.

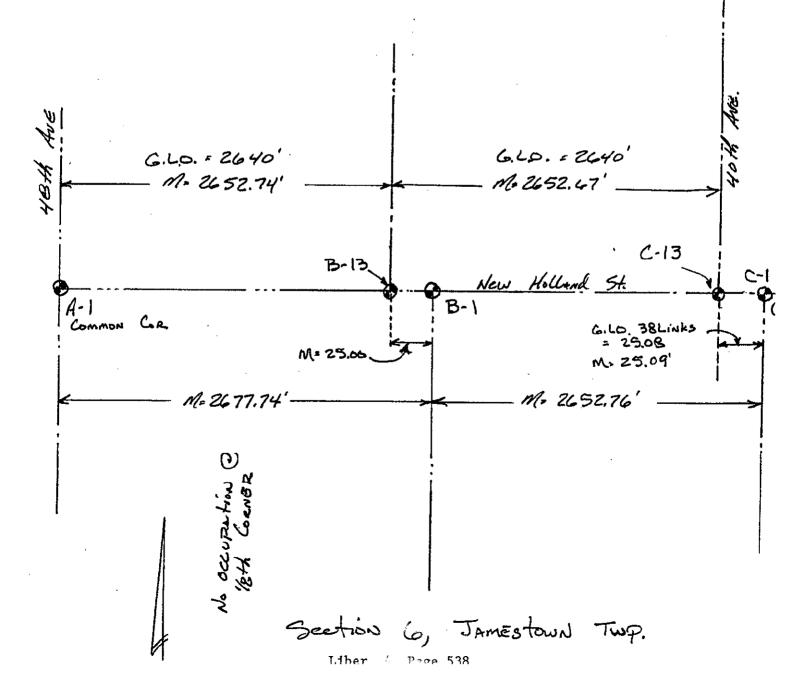
Section 31, Georgetown Twp.

B-1 from Nederveld Associates
Survey Notes November 1980
Found Boat Spike
Nail & MSHD Tag in S Side Telephone Pole NE 42.62'
Nail & MSHD Tag in S side Power Pole WSW 91.27'
S 1/4 corner Section 31, T6N, R13W 25.04'
Found PK in Power Pole ESE 77.58'

B. Description of corner evidence found and/	or method applied in restoring or reestablishing con	ner;		
B-1 Found RR spike in blacktop 0.06' South of Town	line and boat spike below			
Fnd Nail & MSHD Tag S. side P. Pole S76°W 91.25' Found PK Nail in N side P. Pole S66°E 77.55' Center of RR Track (Perpendicular to track) NW 50.55' Found Ottawa County Remon Cap West 25.00'	This position not established by original government surveyors. Accepted RR spike with underlying boat spike as the best available evidence of the position of the corner.	Replaced RR spike and underlying boat spike with a 3/4" X 24" Steel Bar with Remon Cap in Monument Box on Township Line

B-1 3/4" X 24" Steel Bar with Remon Cap in Monument Box on Township Line
